## Array of 120/140/140A Gas Caps

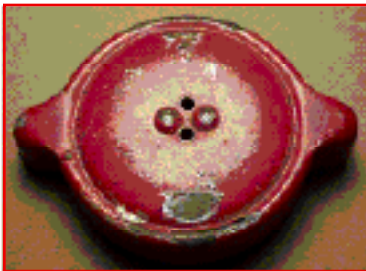
The original two hole gas cap for the 120/140's

Free air/vapor passage with the original cap. The Monarch requires a pressure to open in or out.

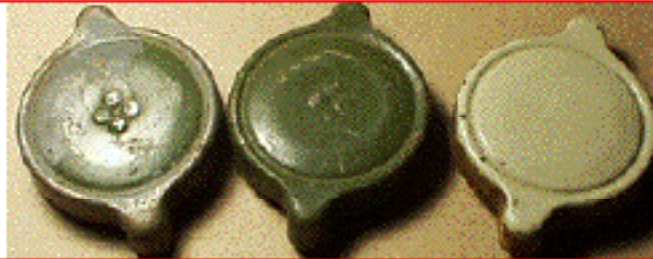
The 140A cap, shown incorrectly in the parts manual as the two-hole cap, actually had the two hole cap whose holes were filled with rivets as shown on the left. In the middle, the next generation, still with rivets in the holes but neater. On the right, the final cap with the indents of the spot welding barely visible through the paint and no rivets.

Because the A model has the open vent above the wing and a juncture which joins a tube to both tanks, the cap had to be a zero flow type in order for the ram pressure to not force fuel out of the caps.
