Oil Temperature Assembly for the Continentals

Mis-Matched Scott Oil Temp Assemblies The Path to Here:

SERVICE INFORMATION LETTER

P/N 13340-00 OIL TEMPERATURE GAUGE (FORMERLY REFERRED TO AS RN-2100 OIL TEMPERATURE GAUGE)

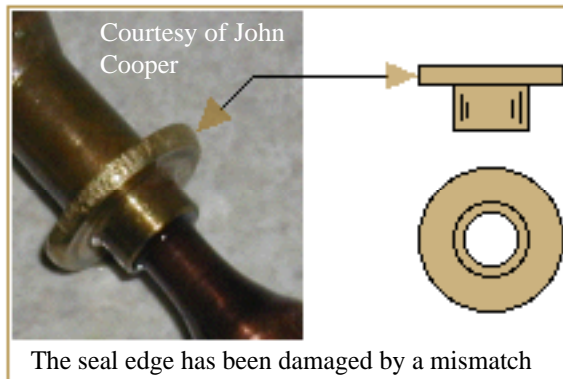
One member elected to use an existing adapter (prettier) that came with a replacement screen assembly; he re-installed the plane's old sensor capillary unit without realizing that the interior sealing surface did not match the shape of the surface on the oldie. The existing adapter had the conical surface whereas the old capillary unit had the flat sealing surface. The result is indicated in this segment of the superb picture he took of the destroyed sensor. The force of the nut on this flat type seal was such as to try to make it conform to the conical surface; the leak never stopped, the seal was damaged, and an annular portion of the seal disc was sheared. He purchased a replacement gauge assembly (with the tapered seal surface) and said this: "...the unit I got came with the correct adapter, and does not leak. Considerable damage to my pride and wallet, and, as I said, the new one is unreliable. I have flown for as much as 1.5 hours without the gauge registering. No amount of tapping on the glass will free it. It seems that given an opportunity to cool down partially, it always starts working again".

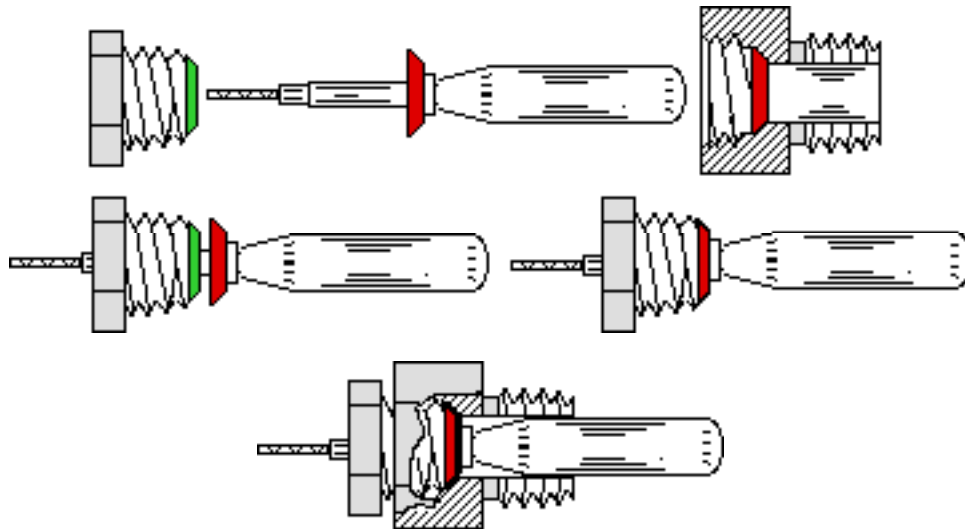
This time, backing up a step to show the sensor inner parts “without clothes” allows a greater detail of the shape of the sealing surfaces, no longer the flat annulus and the flat seat, but with matching inner and outer cone shapes for the seal. To work, the “nut” of the oil temp assembly must have a conical nose, the inner and outer shapes of the sealing portion must match the angles of the nose, and the seat in the adapter must be conical at the same angle as well. The top figures show this relationship. In the middle is the assembly combination nesting. At the bottom, the combination of the oil temp assembly and the adapter, showing how, when the nut is tight, the four conical surfaces will provide the leak-free seal, again for 30 or 40 years.

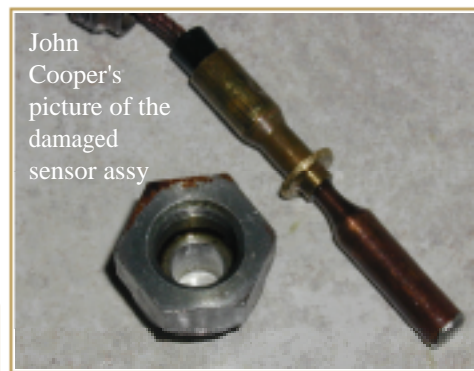
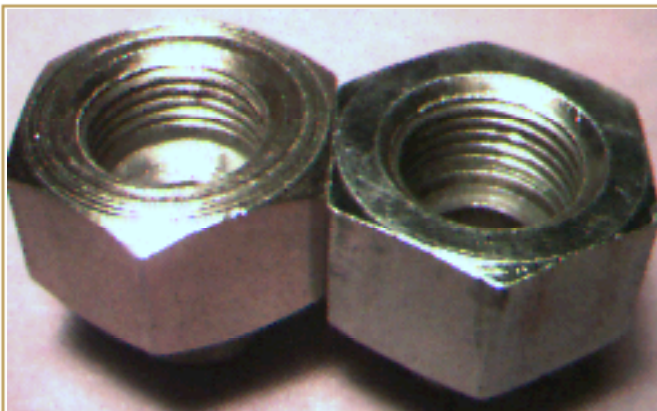
This is a drastically reduced image of the superb picture John Cooper sent of his damaged, original sensor, along with what would have been the correct (flat seal surface) adapter. Not realizing the need to observe and match sealing surfaces in the adapter and the capillary sensor, he replaced the correct adapter with an incorrect adapter having the conical seal surface and reinstalled the sensor, causing a leak and damaging the sensor.

Pictures of the two adapters, with the conical sealing surface on the left and the flat sealing surface on the right. An illusion suggests that the conical surface is larger in diameter, but both surfaces are the same diameter and are the same as the peaks of the threads. Note, too, the difference in surface finish quality. Items from Jim Williams.

The left figure shows the dual adapter set sent to me by Jim to see the two types he had received with two orders, one with the flat internal sealing surface (on the right) and one with the conical sealing surface. It allowed me to confirm what he had said about the poor workmanship which leads to a non-stoppable leak because the sealing surface of the unit on the left undulates because the machinist allowed the tool to chatter. Scott is believed to be checking with their vendor and the design to find out why the wrong combinations and why the poor workmanship. In his discussion with them, it was not established whether the fault lay with a poor spec (the surface flatness not called out) or print, or poor workmanship.

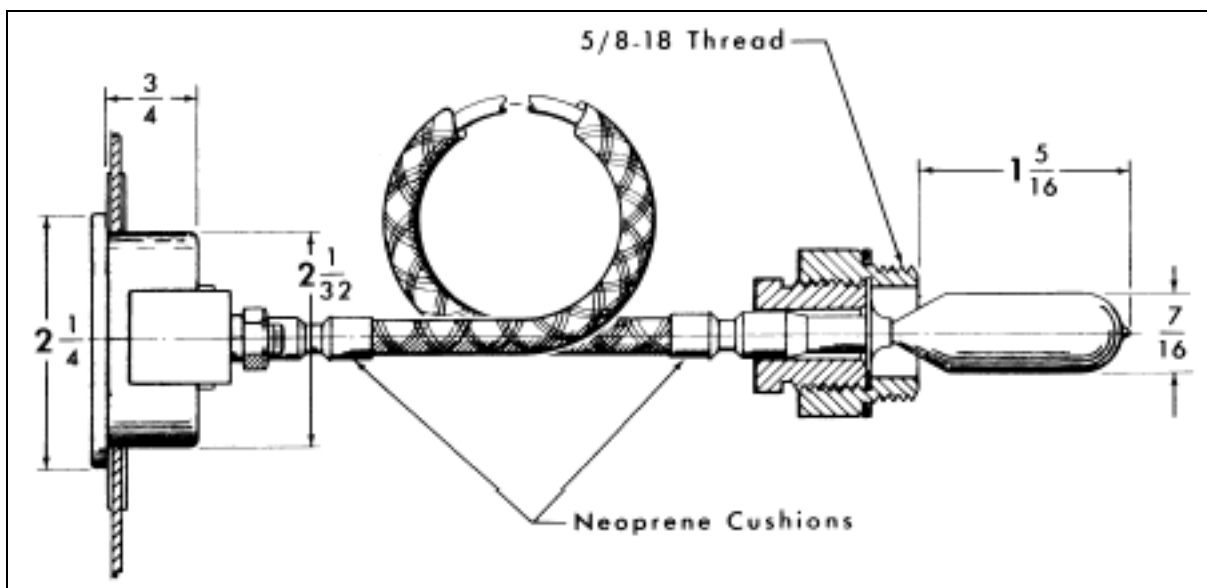
This figure is better than most of Scott's and it comes from the newest Avial parts CD. Note the flat surface areas for sealing between the adapter and the sensor. This is the only figure I know of which has the dimensions, but is incorrect in that the 5/8-18 internal threads and the 5/8-18 external threads should have the same diameters. Sigh. I present it here because of the dimensions, especially that of the meter body diameter, a number often misleading in the catalogs.

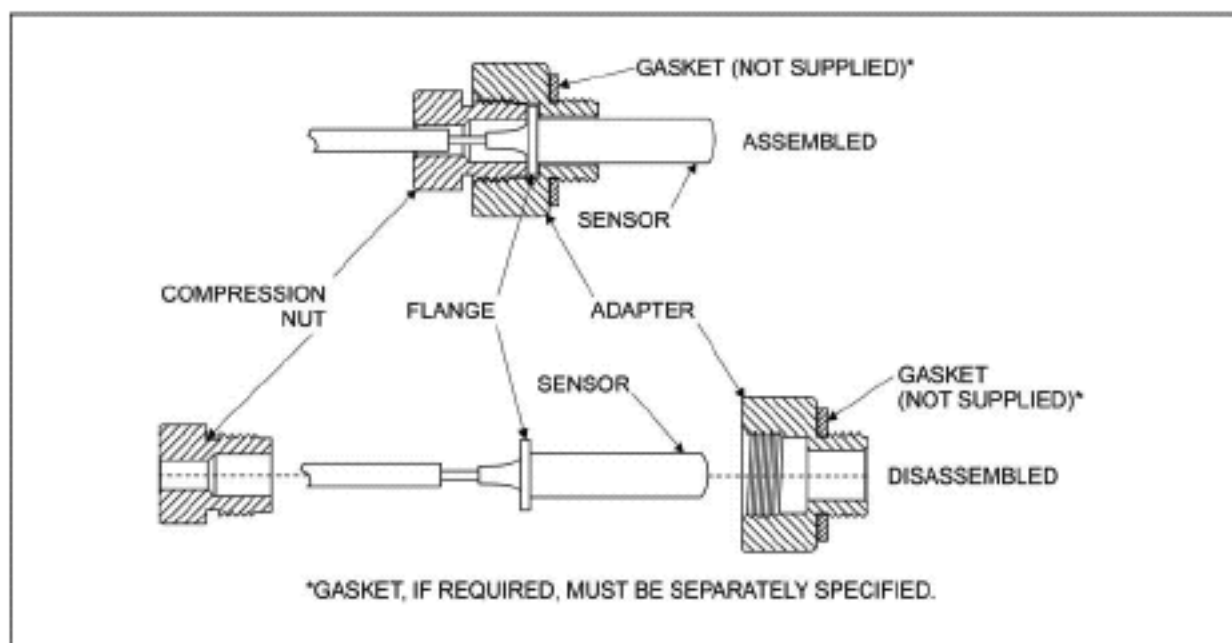
Figure 2
Square Type Flange

Two different types of oil temperature sensors have been supplied on the 13340-00 gauge. The earlier type, manufactured before 1998, had a flat flange at right angles to the sensor as shown in Figure 2. The current type, manufactured during 1998 and later, has a conical shaped flange on the sensor as shown in Figure 3.

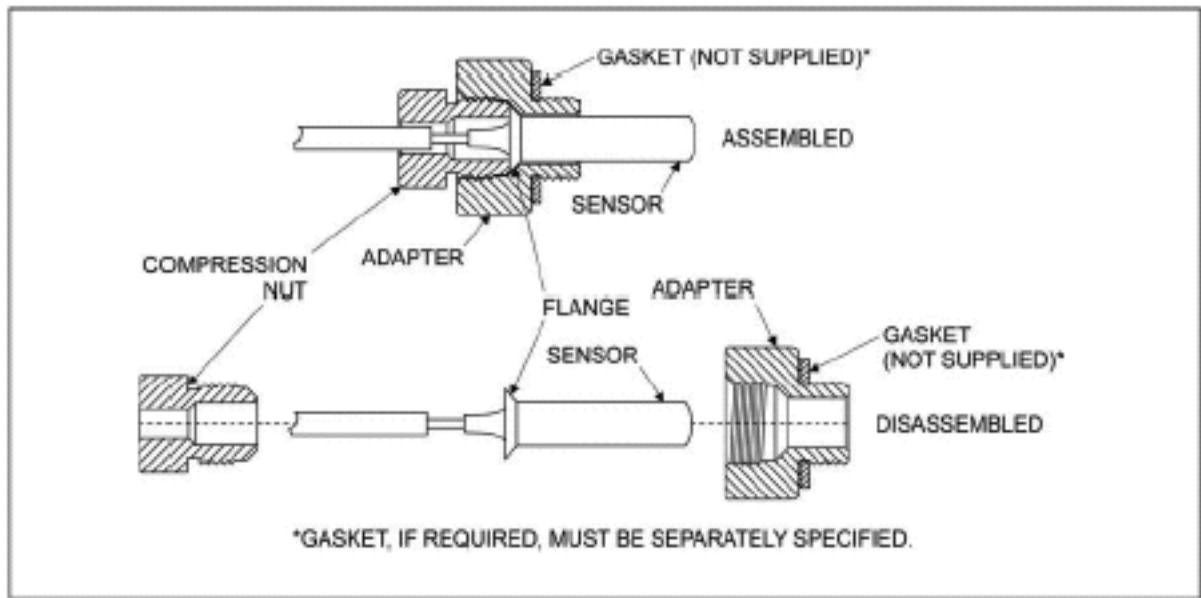
Figure 3
Current Conical-Type Flange

The current design of the gauge has conical mating surfaces as shown in Figure 3. The compression nut and the sensor are assembled at the time of manufacture and cannot be separated. The adapter must be a separate part to accomplish the installation.

If the wrong adapter is installed, the mating surfaces may not seal. For example, if a new gauge is purchased, but the already installed flat-faced adapter is not removed and replaced by the new adapter, then the conical mating surface of the sensor and the compression nut will not seal with the old flat-faced adapter. Installation of a new gauge with a conical flange and compression nut into an old adapter with a flat surface can result in damage to the sensor and loss of engine oil.

When installing a replacement gauge, it is critical that the compression nut, sensor bulb and adapter making up the complete oil temperature gauge be installed together. Make sure to remove the existing adapter from the engine, then install all three new parts.

Refer to the engine manufacturer's manual or maintenance instructions for the correct gasket if a gasket is required. If you find an oil leak at the adapter to compression nut joint and a mismatch is suspected, replace the entire gauge assembly (including the adapter).

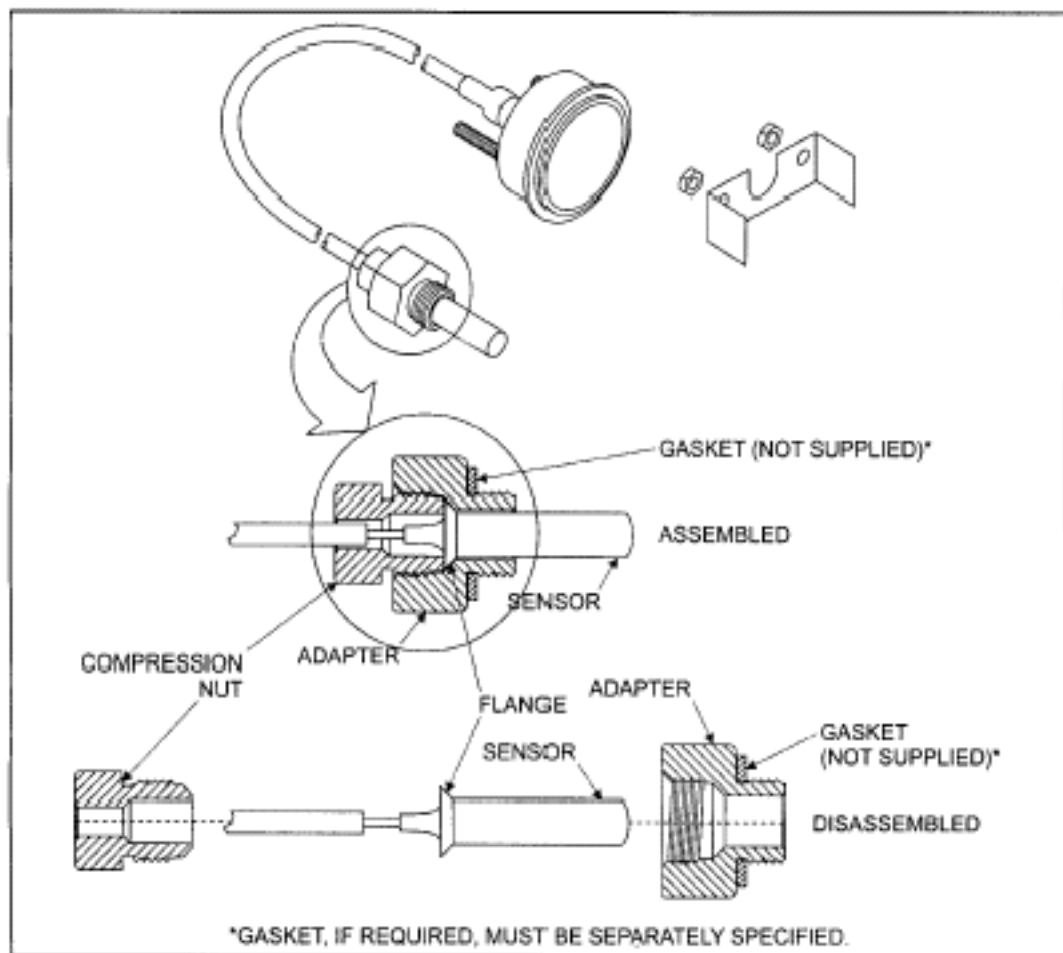
The next figure is the “instruction sheet” which is now packaged in each kit for the oil temp sensor assembly. Miss the admonition about never leaving the existing adapter in place when changing the oil temp sensor and you leave yourself open to a possible leak.

When installing a replacement gauge, it is critical that all the components of the original gauge be replaced. Make sure to remove the existing adapter. When installing the replacement adapter, refer to the aircraft/engine maintenance instructions for the appropriate gasket if required. Torque the new adapter to the engine/aircraft manufacturer's specifications, but not less than 12 to 15 lb ft (16.3 to 20.3 N•m).

Carefully insert the oil temperature bulb into the adapter. After insertion of the bulb, torque the compression nut to the engine/aircraft manufacturer's specifications, but not less than 12 to 15 lb ft (16.3 to 20.3 N•m).

Never attempt to install the sensor directly into an engine without the adapter.
