## Antenna Problem Plagues Narco ELTs

Filed as: Narco ELT-10 Correction Aug '05  
Neal F. Wright cougarnfw@aol.com

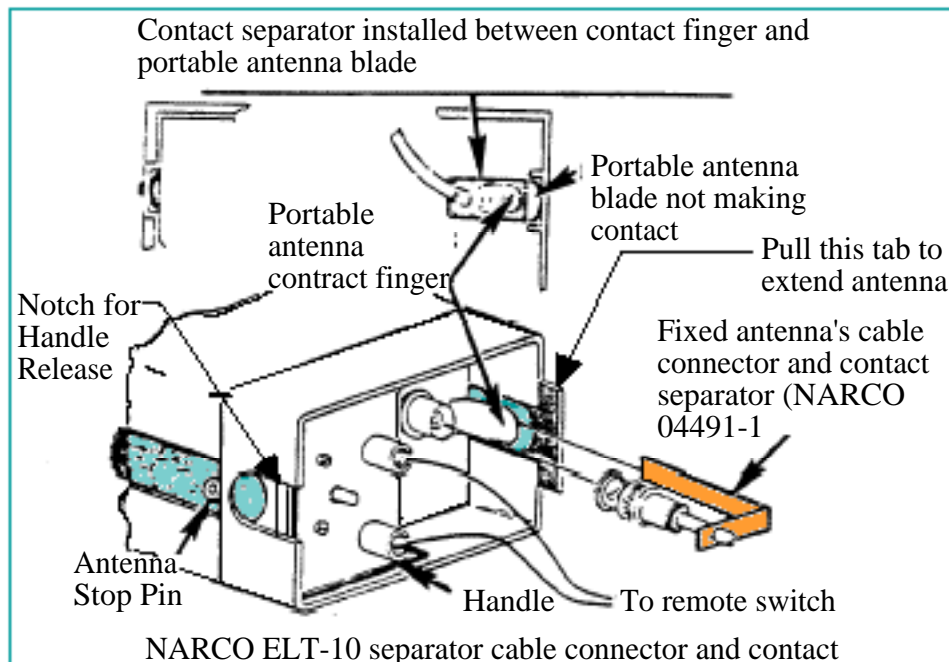
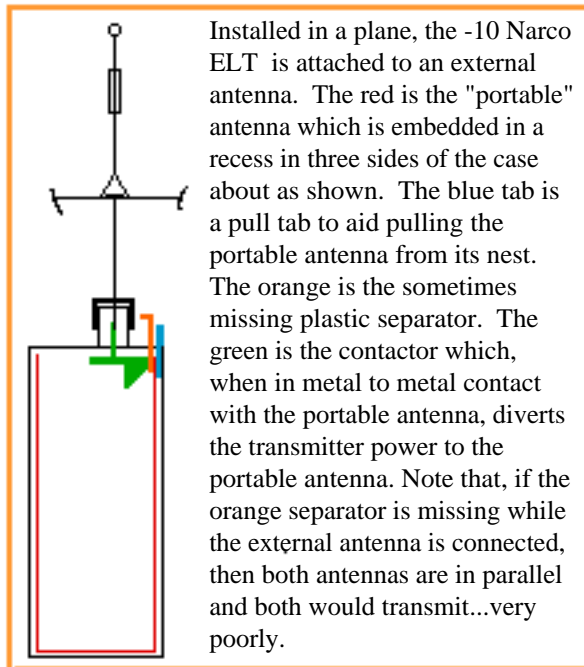
Their figure which was part of the report is the next one and it shows some details I do not have in my sketches. I have highlighted the contact separator in orange. Note how it was attached to the coax cable and how, when the external antenna cable's BNC is disconnected, the contact separator comes with it and so the portable antenna is the only one connected, as it must be to work properly.

The problem involves the Transmitter's antennas. The FAA problem reporting form at the beginnings explains the fault that was found: "the reports indicate the absence of the ELT's fixed antenna's contact separator or its misposition". The contact separator should be between the portable antenna contact finger and the antenna blade. Note the blue separator in the figure.

If the separator is not in the correct place, then both antennas are connected to the output stage, and this causes an extreme degradation of the distance the ELT transmits.

In the event your separator is long gone, make a plastic separator which will serve and stay there, and do it soon. If you can, make a note on the separator as to where it should be placed...for those who don't realize the purpose, a non marked separator might be removed by those not in the know "as a favor" to make it "look right".

Narco has been known for the previous years of being abominable as to service and availability but if you want to try, the correct part number of the separator is: 04491-1.

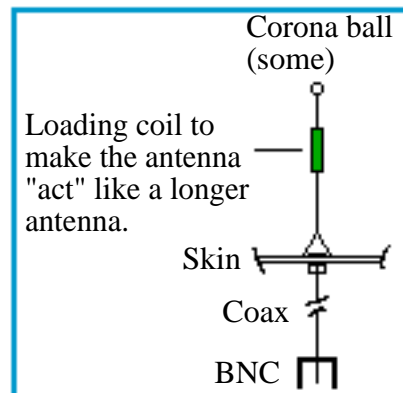
When the coax cable's BNC connector is attached to the BNC of the ELT, this external antenna is the only one which can transmit...if the separator is in place.

To the left is an illustration which shows the plane's external antenna not connected, the portable antenna pulled to its full length and a good contact between the antenna and the tab which passes the output power to it.
