CESSNA 120/140 CONTROL TUNNEL MODIFICATION

THE ONE WHICH CESSNA NEVER TOLD ANYONE ABOUT

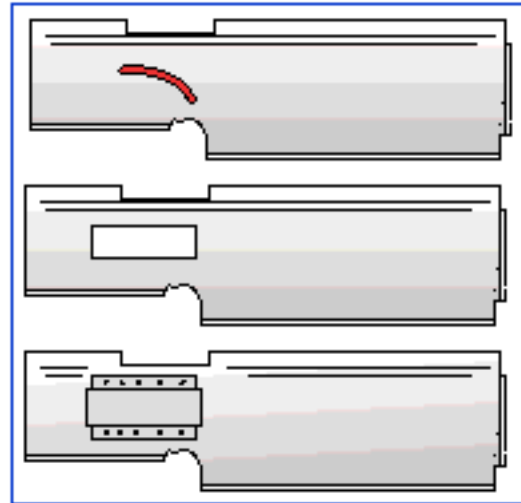
In the beginning, as the old stories start, Cessna assumed there was clearance between the rudder bellcrank bolt and the centerline control tunnel, but the users soon proved there was an interference. The bellcrank bolt would rub on the inside of the tunnel sides, eventually forcing first a gouge and then an arc-shaped hole as indicated in the first figure. Apparently, the interference never caused an accident because there were no Service Letters issued nor was there an Airworthiness Directive to modify the tunnel to

The modification consisted of two steps: A) a hole was punched in the tunnel on both sides so as to ensure clearance of the bolt, and B) they added a hat section over the hole. The upper figure shows the ugly tear, the center shows the design modification clearance hole (on yours, be guided by the size of the tear or the dents in your tunnel..and there may not be any), and the lower figure illustrates the repair after the hat section is installed. The hat section stands off from the sides of the tunnel about a quarter of an inch and is attached by spot welds.

Since Cessna never let anyone know about the change, there are some planes out there which have the arc-shaped dents or the arc-shaped holes in the tunnels. Most owners, if they realized there was a factory fix, would prefer to alter the tunnel about as Cessna did to increase the clearance between the tunnel and the rudder control mechanisms. Making the change would also prevent damage to the rug which covers so many tunnels these days, and provide the same assurance that the rudder mechanism will never catch on anything while maneuvering or taxiing.

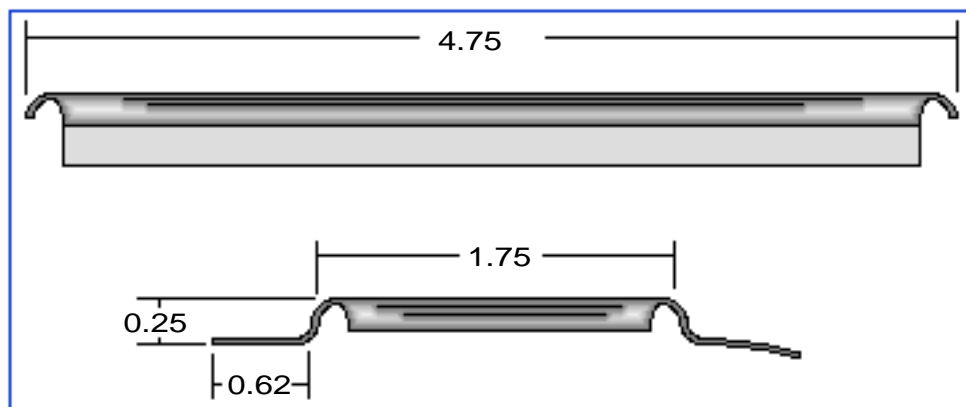
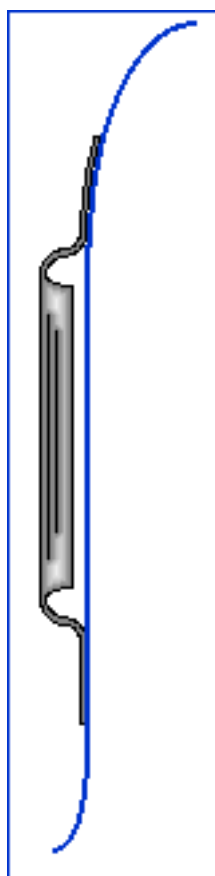
The hat section is about as shown. The two “wings” which get spot welded or otherwise attached are 5/8ths of an inch long, formed as shown so as to be the same shape/curvature as the tunnel.

The dimensions of the hat section for each side of the tunnel are suggested by the accompanying sketches. Note that the dimensions are from measurements from a factory-changed tunnel, so may not be exactly what the prints would show. The Cessna-installed correction hat sections were attached by spot welding, a method not available to us, so we suggest that rivets be used, but, whatever is used, make sure their length inside the tunnel is minimized so as to avoid causing a secondary snagging problem on the inside.

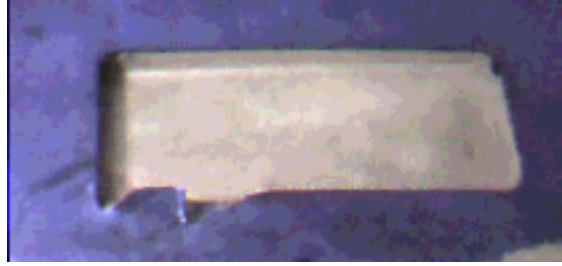
The actual tunnel I used to create these figures showed signs of an interference even with the hat section in place. I have painted the surrounding area of the inside of the tunnel so as to give the picture some contrast so that you can see the damage done.

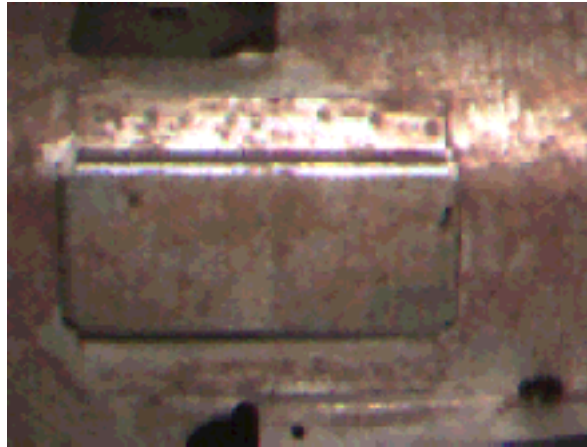
A picture of the outside, showing the right hand hat section, is below. The mottled effect of the surface is the dried contact cement.
