“JUST A LITTLE TRIP AROUND THE PATCH”

THE GASCAP STORY:

The Hazard for 120/140 Planes:

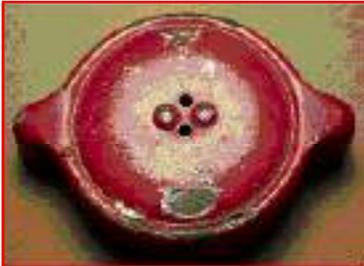
The original two hole gas cap for the 120/140's

Free air/vapor passage with the original cap. The Monarch requires a pressure to open in or out.

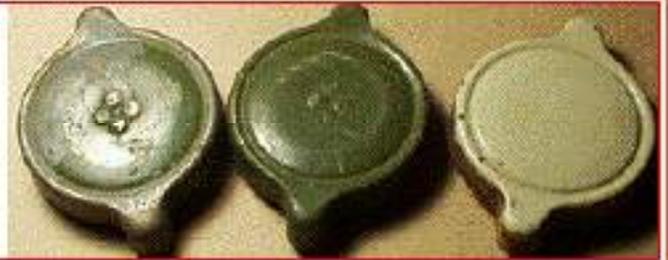
Array of 120/140/140A Gas Caps

Forward-facing cap cutaway (cute) not to be used on the 120/140's except with STC'ed Lycoming, causing problems with them

The Monarch cap

The 140A cap, shown incorrectly in the parts manual as the two-hole cap, actually had the two hole cap whose holes were filled with rivets as shown on the left. In the middle, the next generation, still with rivets in the holes but neater. On the right, the final cap with the indents of the spot welding barely visible through the paint and no rivets.

The silicone valve, opens in but never out.

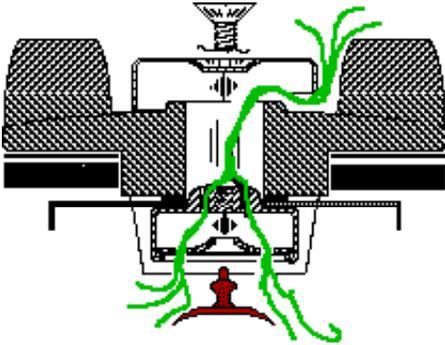
The Half-Vented Mandated Cap:

The text refers to a "half-vented" gas cap though that term will not be found elsewhere; I use that name because that is what it does and no other name so descriptive has appeared in the research. It is "half-vented" in that it allows air inflow to the tank when the vacuum created in the tank by fuel usage exceeds an undefined and never tested value but prevents any outflow of air or fumes or even fuel when the fuel expands from heat and/or altitude. Others call it "the red cap", "the 150 cap", "the cap with the hat" and so on. They (there are two manufacturers) are nicely designed units. The action of the original version appears as something like this representation.

The silicone valve does not move to permit venting until a significant vacuum has been created in the tank by fuel usage. OOPS!! No one knows, and the FAA did not stipulate in the AD what amount of vacuum is needed to make the valve deflect to let air in. Consider going to your plane, attaching a vacuum cleaner to the stem of the gas tank, applying the vacuum, and noting that the flow from the gascolator diminishes until none flows if you apply enough vacuum. Maybe not such a good idea to create a vacuum in a gas tank on a plane designed to NOT have a vacuum in the tank?

If your plane is a 120 or 140 that has the new-style gas cap, and you don't want the hazard for an hour longer, but you have to get home, then you can render the half-vent caps full-vent by removing the silicone valve. For the short term use, say a trip or two, the half-vented gas caps can be made safe for our 120/140's if the red silicone valve is pulled out, a step that can be easily accomplished. Realize that a mechanic or fuel person might subsequently notice the silicone valve being missing, not know why, and re-install a new silicone valve or like cap but again with the silicone valve. If you have one or two half-vented caps on your Cessna 120 or 140, get that valve out of there, make a note in the logs, and go back to the original gas caps with their two-way vent holes as soon as you can!! Be safe.

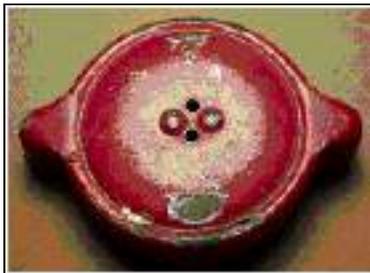
The Originals:

The original caps for the Cessna 120's and 140's look like this, with the two vent holes as shown providing air inflow or fume outflow without restriction. They are both-way vents since fumes can exit and air can enter without any valve interfering.

Marking denoting the name of the maker or a part number, which, according to FAA rules, has never been seen on this part.

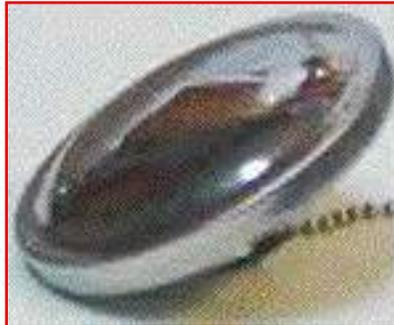
Monarchs:

This is a picture of the Monarch cap which also causes engine outage on climbout. It was approved by the FAA because of inadequate research by the seller and the FAA, and driven out of business because of their failures in 2004.
Neal
