Cessna Throttle Control Attachment Replacement

SE79-6

SUBJECT: ENGINE CONTROL ATTACHMENT

2 86-24-07

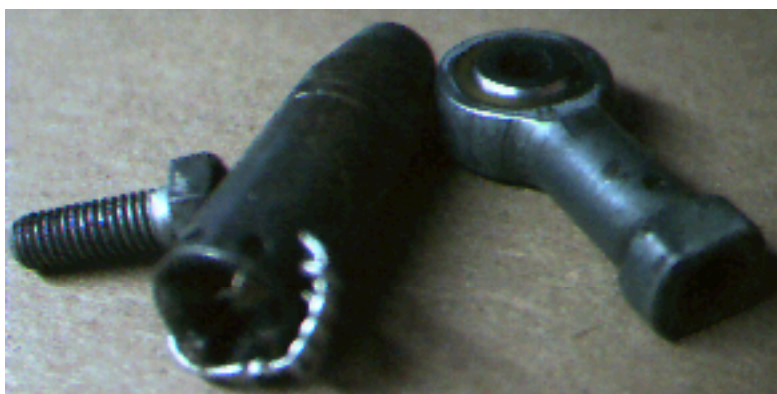
These are the two types of carb throttle devices which attach to the throttle arm of the carburetor and to the 10-32 threaded end of the throttle cable.

On the left, the old type. In the body is a spring pushing on a 'cup' which presses on the ball shaped end of the swivelable portion with the threads and hex and the ball end. The threaded portion is secured to the throttle arm and what appears to be an open end of the body contains a "screw" which can be repositioned to change the pressure on the ball shaped end for easy movement but good tension. After tightening, the threaded part is secured with the safety wire.

Too many of these came loose, so the termination end was changed to the style on the right. The bearing permits accommodation of the different angles of the throttle end and the throttle arm as the throttle position is changed. An AN-3 bolt drilled through at the threaded end goes through the bearing and the throttle arm with spacers as required to align and a locking nut (castellated nut and cotter key) to secure the assembly.
