JACK'S MARVEL, NOVEMBER '04

Jack's carb in November '04, removed because the engine would not start when being primed by the use of short strokes of the accelerator pump/throttle. He had been advised many times to not use the accelerator pump at engine start but to use the primer. This, time doing it wrong uncovered a significant fault.

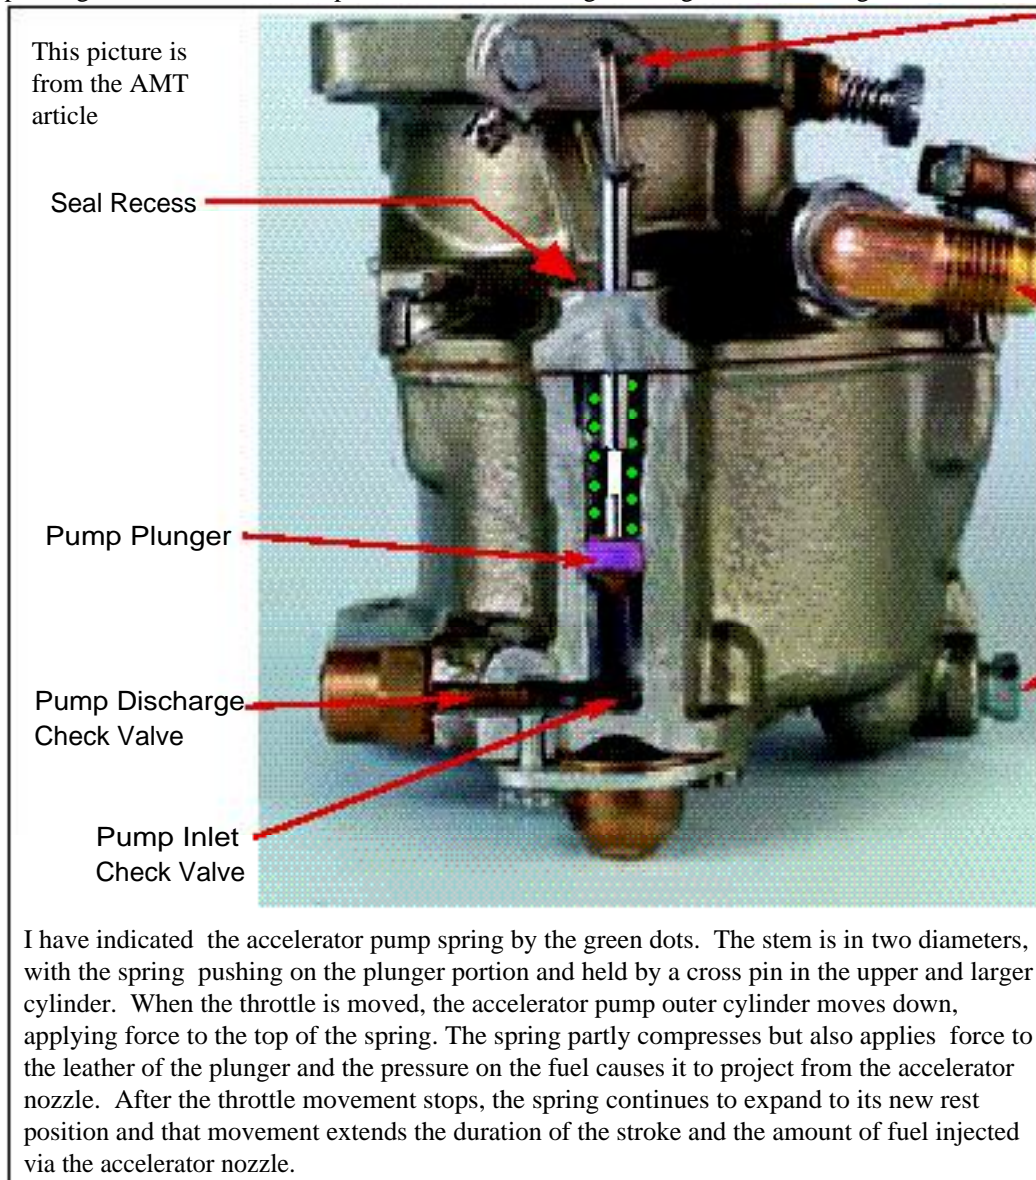
Corrosion at the top of the accelerator pump chamber, rust on the stem and the tension spring of the leather seal, but zero corrosion inside the carb so the water which did the damage was not from the main fuel chamber. This picture is from AMT.

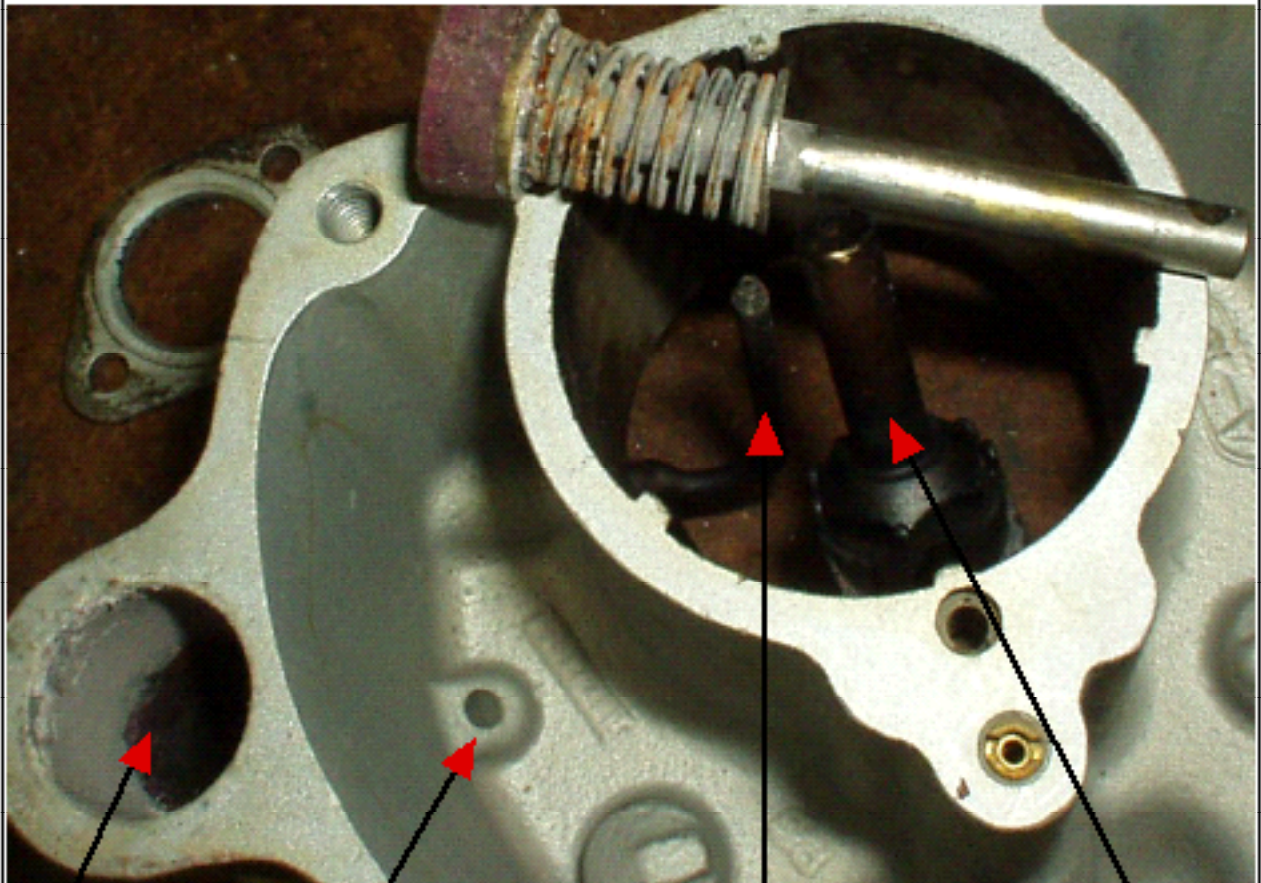
Pump well

Fuel path to the accelerator pump chamber. The pump inlet check valve prevents the fuel...and water...from backing up into the main fuel chamber.

The main fuel nozzle. It doesn't appear to have any outlets, but they are there.

The accelerator pump discharge nozzle. If you leave any fuel in the pump chamber and are foolish enough to be looking down at this item, the fuel jet will hit you if the pump is fully pulsed.

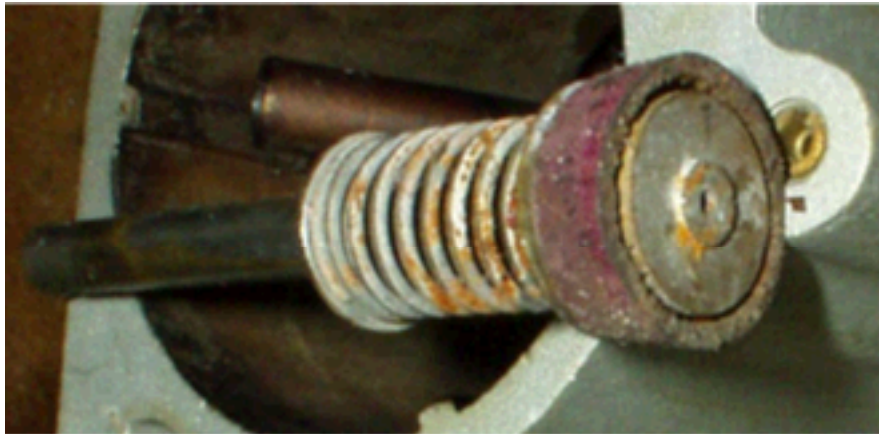
Below, the done-in accelerator pump, well rusted. Although barely apparent here, there is a coiled tension spring underneath the "leather" which applies outward force to keep the leather tight against the well wall. There apparently came a time when the rust junk caused the water held at the top of the purple leather to seep beyond the seal and caused the rust you see at the bottom.

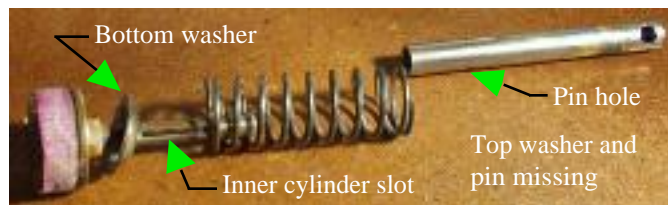
The pump, first showing the "As Removed"

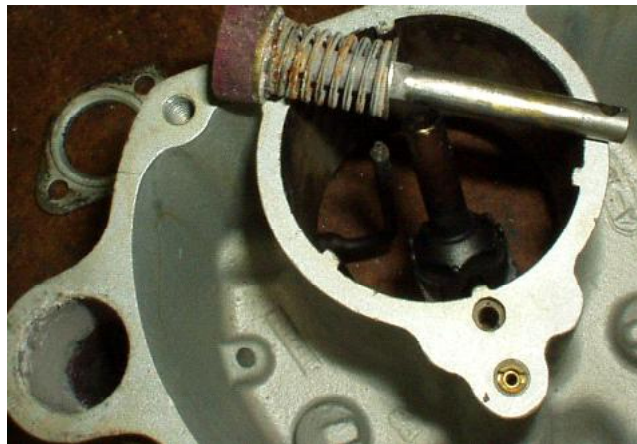
A more inclusive view of the pump action end and the pristine interior of the bottom casting. That hole on a slanted boss at the left is where the gas from this chamber goes to the accelerator pump reservoir. Note not a whit of corrosion.

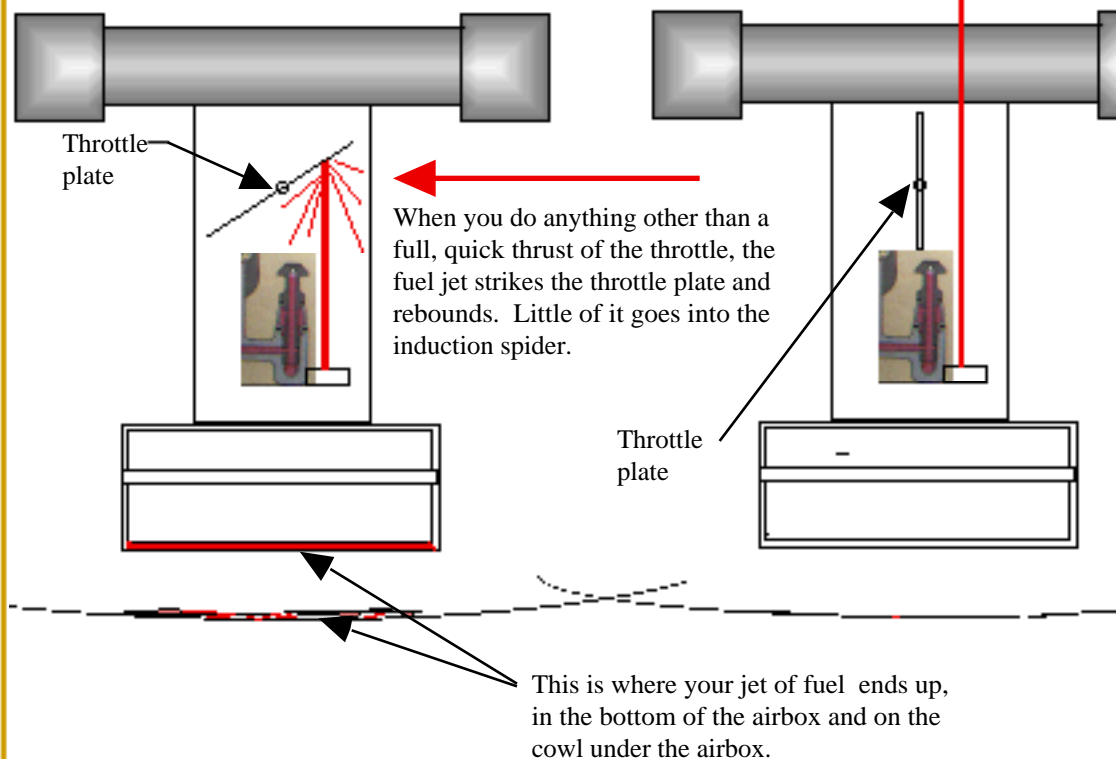
Great liberties were taken with respect to sizes and features in these figures. The air box, carb outline and induction spider are meant to provide the setting to show what happens when a partial thrust of the throttle/accelerator is used. Most of the fuel jet rebounds from the throttle plate and ends up in the bottom of the airbox and cowl, there to await ignition.

For Marvel users, unless you do a full, swift plunge of the throttle, little of the accelerator stream of fuel will get by the throttle plate!! Do not partially open and close the throttle before or while starting as this is likely to deposit raw gasoline in the air box and constitute a fire hazard. The fuel which rebounds off the throttle during a short thrust falls back into the air box. There, it constitutes a fire hazard in the event of a backfire.

If you use a **full quick thrust of the throttle**, most?? of the fuel goes up and strikes the top of the induction spider. The jet, if there were nothing in the way, would go up 36 plus inches.

USE THE PRIMER!! No book tells you not to use short strokes of the throttle/accelerator pump for engines with the Marvel carb so they do not explain the result as noted in the sketch. Continental and Cessna books say the same thing...use the primer to introduce fuel into the induction spider.

Things to remember: A. The carb is never empty of fuel until the accelerator pump is cycled and no fuel comes out anymore! B. Never, ever, be looking down the throat of the carb when the accelerator pump is manipulated!!!!

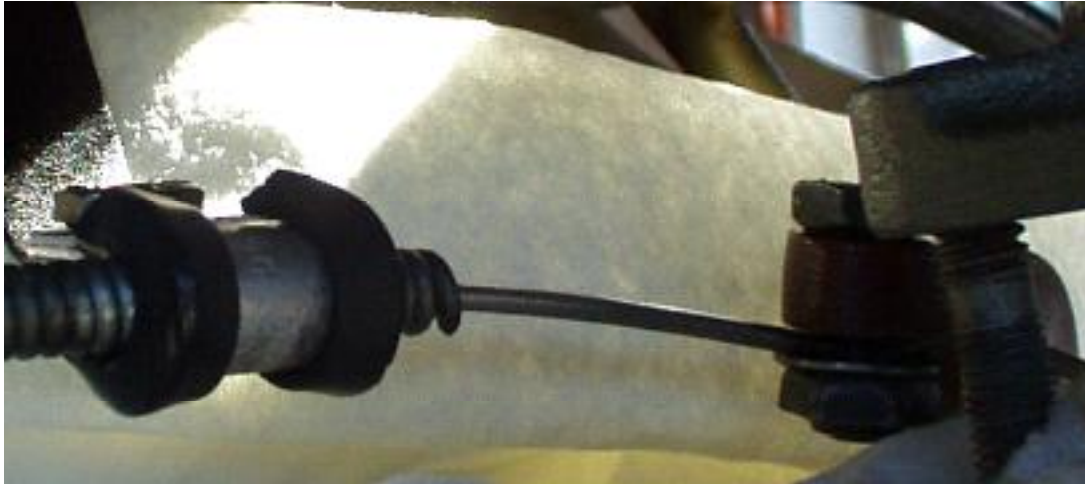
When this carb was installed in July, after the same repair, the hardest part of the installation was to get the push-pull cable wire and the clamp and the spiral guide and the mixture control arm and its stops all in sync. For the re-installation, this feature will be the first to be connected so as to have the most knuckle room for the tightening of the bug nut holding the push-pull cable wire. Whew!

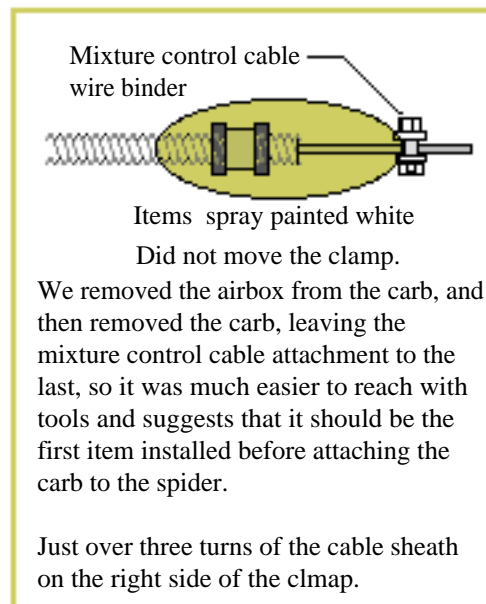
Just before loosening the bug nut which holds the push-pull cable to the mixture control arm, we painted a sector to include the push-pull sheath, the clamp and mount, and the bug nut such that we could reconnect the wire in the same positions. Later, after the re-installation, the paint worked as planned. No additional jiggling of the parts was necessary to get the mixture control arm to go from stop to stop.
