Cessna 140 Flap Spring and Bell Crank Repair

CESSNA 140 FLAP SPRING REPAIR

C1401-SPRING-01

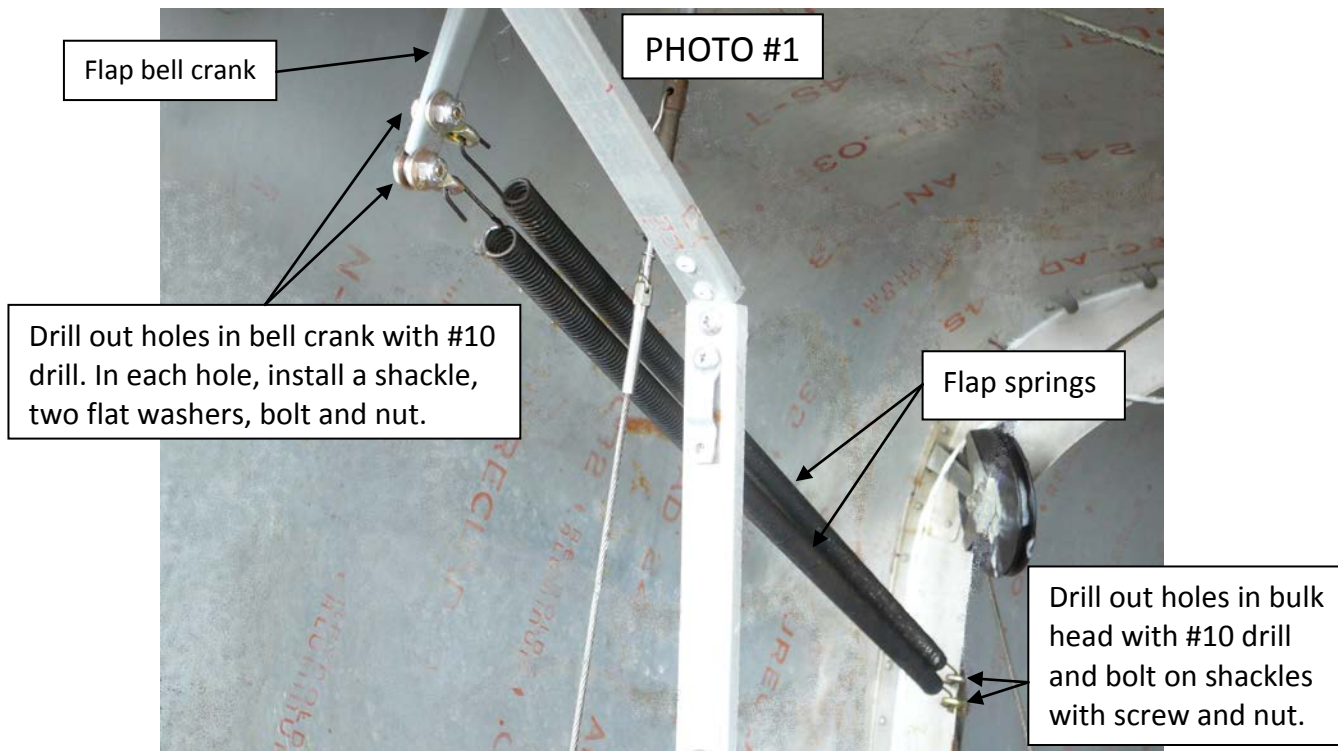
After removing the flap springs, drill out holes in bulk head with #10 drill and bolt on shackles with screw and nut (see photo 1).

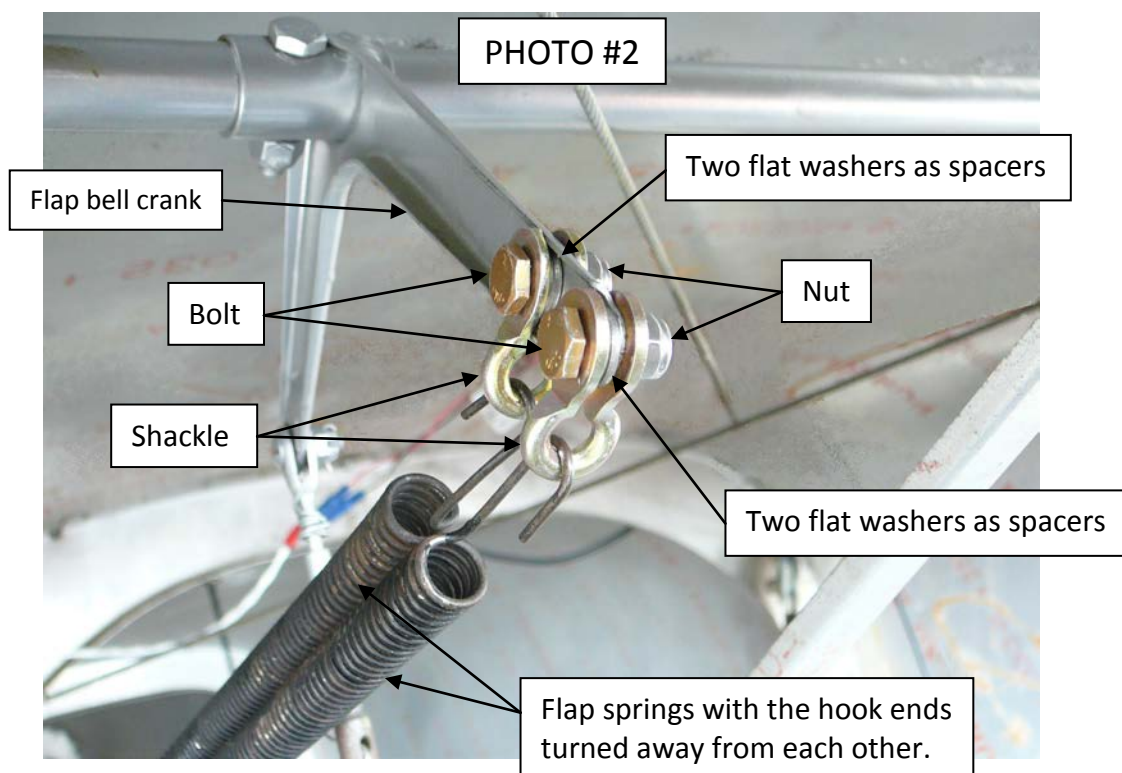
Second drill out holes in bell crank with #10 drill. To keep from bending the bell crank, support it with a block of wood. In each hole, install a shackle, two flat washers, bolt and nut. Because the bell crank is shaped like a channel, the washers are used as spacers to keep the shackle from crushing the crank. Note the ears on the two shackles must be spread apart in order to fit around the bell crank (see photo 1 & 2).

Finally, clean and spray the springs with silicon. Then hook the repaired springs in the cable shackles with the hook ends turned away from each other (see photos).
