## " JUST A LITTLE TRIP AROUND THE PATCH"

### THE GAS CAP STORY:

Submitted by: Neal F. Wright

### THE CULPRIT, THE SILICONE VALVE

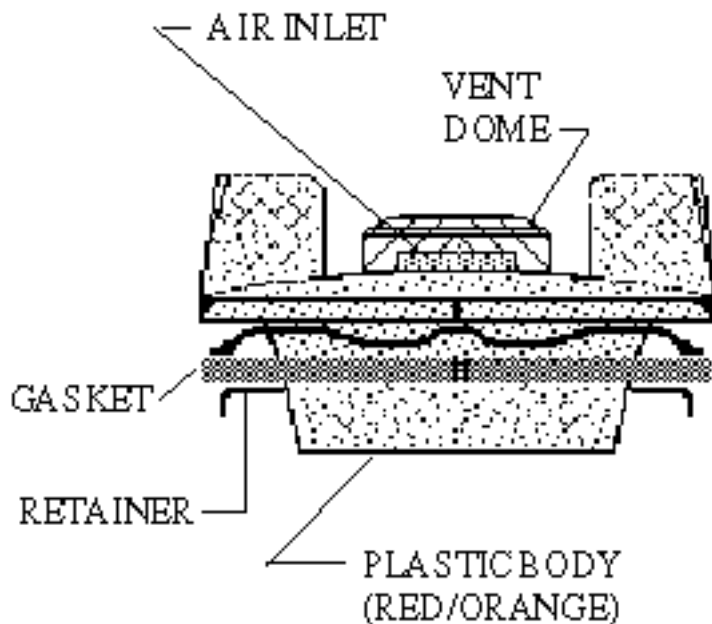
A side view of the half-vented tank cap, the style mandated for the 140A and newer/larger Cessna's in order to provide an alternate source of tank venting in the event the original primary external vent became clogged.

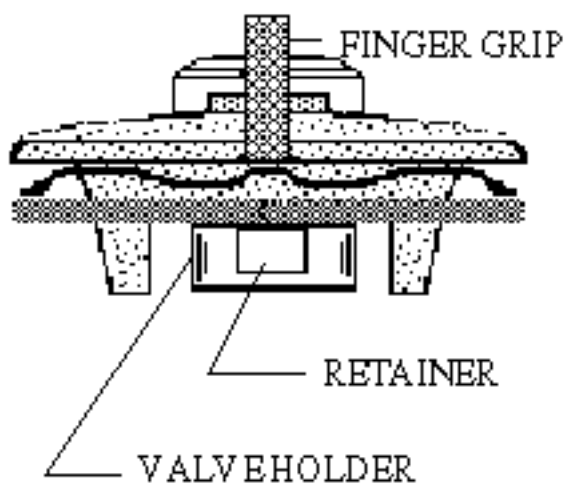
A rotated view of the half-vented tank cap. The cap is nicely made, but the manufacturer must be ashamed of it since it has not a single marking denoting the name of the maker or the city in which it was made nor even a part number.

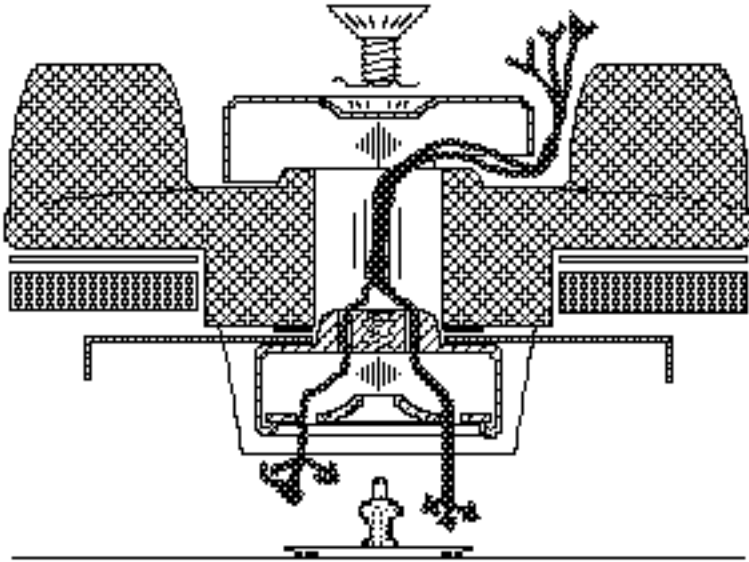
A fully sectioned gas cap, showing the silicone valve displaced to better depict the flow and path of the incoming air.

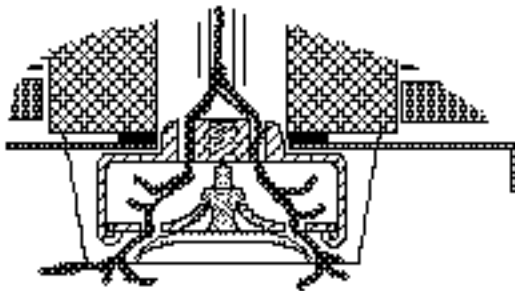
The important portion of the cap showing the silicone valve open to let the outside air into the tank. Note that the silicone valve is shown as though it had two wings, whereas it is really round and would appear more as shown in a later sketch.

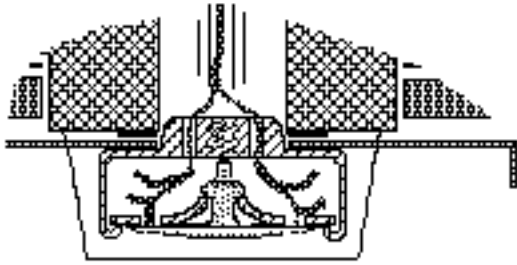
The same view, but with the silicone valve in the closed position, as it would be if the pressure on the tank side is the same or greater than the pressure outside the tank. The airflow, of course, is shown halted. Not only fumes can't get out, but fuel can't get out if it happens to expand from being heated by the sun. If the pilot takes off using the left tank, and if the right tank has the half-vent cap, then there is a hazard, too, if the pressure builds up as the altitude increases!!

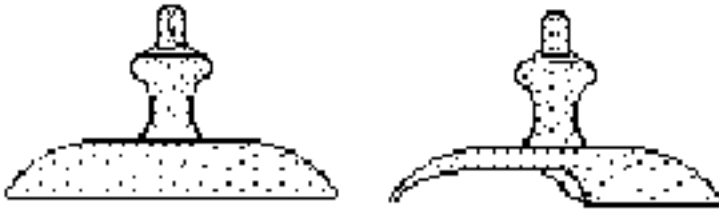
The silicone valve in a simulated and exaggerated open condition, appearing something like an umbrella that has been turned inside out by a high wind. The material and shape of the valve ensure that the valve is very pliable.

If your plane is a 120 or 140 that has the new-style gas cap, and you don't want the hazard for an hour longer, but you have to get home, then you can render the half-vent caps full-vent by removing the silicone valve. For short term use, say a trip or two, the half-vented gas caps can be made safe for our 120/140's if the red silicone valve (that is what the manufacturer calls it) is pulled out, a step that can be easily accomplished; realize that a mechanic or fuel person might subsequently notice the silicone valve being missing, not know why, and re-install a new silicone valve or like cap since they are readily available at any Cessna FBO. The silicone valve itself is available for only \$5.00 to \$7.00 for the plastic cap model and \$12 for the metal model, so beware someone doing another favor by re-installing it when you thought you had disabled the valve. If you have one or, god forbid, two half-vented caps on the wrong plane, your Cessna 120 or 140, get that valve out of there, make a note in the logs, and go back to the original gas caps with their two-way vent holes as soon as you can!! Be safe.

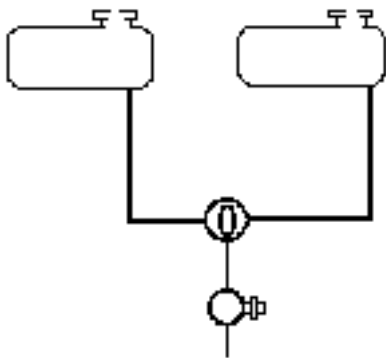
The Cessna 120 and 140 version of the fuel system, vastly simplified to show only the typical full-vented gas caps and the lack of any tank vent interconnect or external vent. Note that, if one tank inlet vent is blocked, such as was the case for the subject 140, there is no other source of inlet air to replace the volume of fuel used. Note, too, that if a tank vent is outflow blocked, there is no way for internal tank pressure from sun heating to escape; the half-vented caps are that style-----they prevent any outflow of air/fumes or even fuel and are meant to allow only inflow-----if the silicone valve doesn't stick!!!!

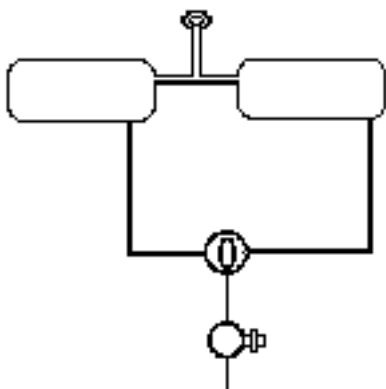
The "normal", as-designed Cessna 140A fuel system, again simplified and stylized to show only that there is a tank vent interconnect tube attached to the new top-of-the-wing vent. It is obvious that, if the single vent is blocked by a hornet's nest or ice, there is no way to get fuel out of either tank after a vacuum develops from fuel outflow. The gas tanks are shown as though they have no filler openings or caps, though of course they do-----part of the problem is that, starting with the 140A, the gas caps were "blind", or ventless, so the venting was totally dependent on the new, external, common vent.

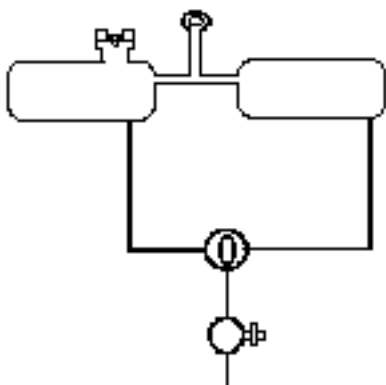
The Cessna 140A tank system shown with the mandated redundant fuel vent gas cap installed. The detail is too small to denote that the cap only allows air inflow as the fuel is used, but prevents any air or fumes or fuel from outflow in the event a full tank of fuel warms up on a hot day or if altitude-induced differential pressure is created.

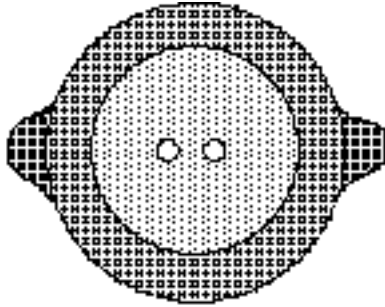
The original caps for the Cessna 120's and 140's look something like this, with the two vent holes as shown providing air inflow or fume outflow without restriction. They are both-way vents since fumes can exit and air can enter without any valve interfering.
