87-20-03 R2 CESSNA: Amendment 39-5729, as revised by Amendment 39-5863, is further revised by Amendment 39-6669. Docket No. 86-CE-71-AD.

To assure proper engagement of the seat locking mechanism and to preclude inadvertent seat slippage, accomplish the following on each pilot and copilot seat and all associated seat rails:

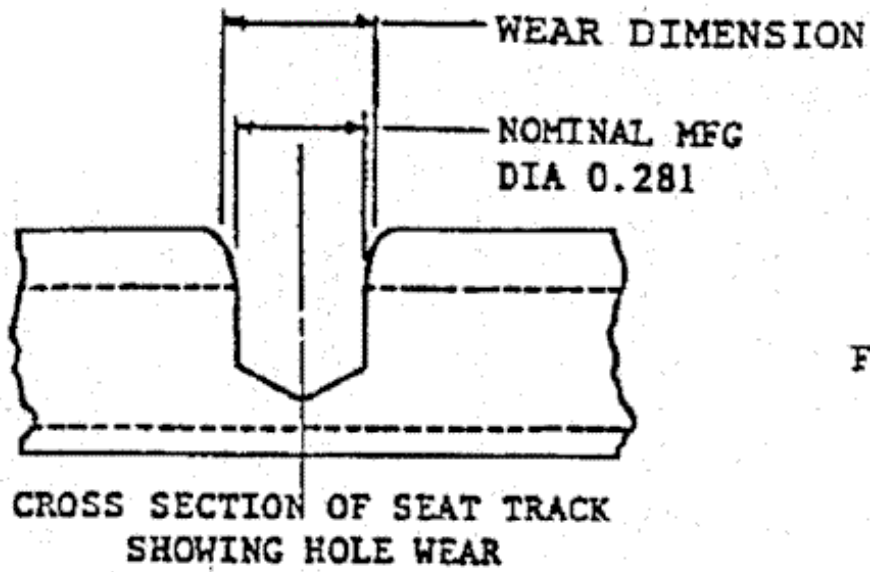
FIGURE 1

(1) Measure each hole in the seat track(s) for excessive wear. When checking these holes for wear, an allowance of 0.020 inches below the edge of the normal surface is permitted for the required measurement.

(i) If the wear dimension across any hole exceeds 0.36 inches but does not exceed 0.42 inches ([see Figure 1](#)), continue to measure each hole every 100 hours TIS for excessive wear.

(ii) If the wear dimension across any hole exceeds 0.42 inches, prior to further flight, replace the seat track.

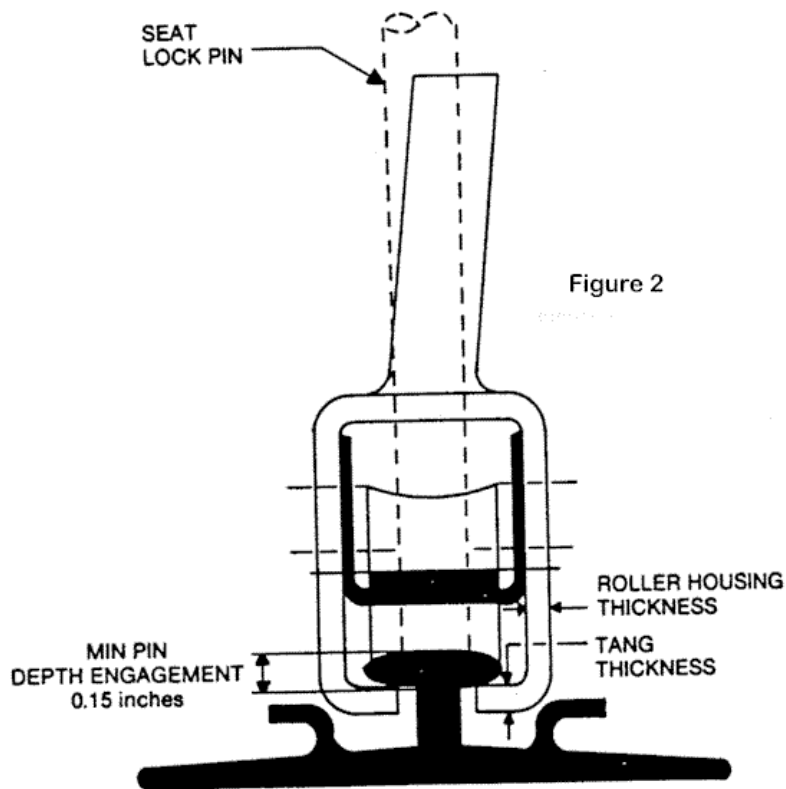
(3) Lift up on the forward edge of each seat to eliminate all vertical play. In this position, measure the depth of engagement of each seat pin. If the engagement of any pin is less than 0.15 inches ([see Figure 2](#)), prior to further flight, replace or repair necessary components to achieve a seat pin engagement of 0.15 inches or greater. If

the track is worn, this dimension is measured from the worn surface, not the manufactured surface.

(5) Measure the wall thicknesses of the roller housing and the tang (see Figure 2). If the tang thickness has worn to less than 1/2 the housing thickness, prior to further flight, replace the roller housing.
