# **G**ENERATORS

For the 120/140/140A's

## **Generators for the Continental C-85, C-90, and O-200 Engines:**

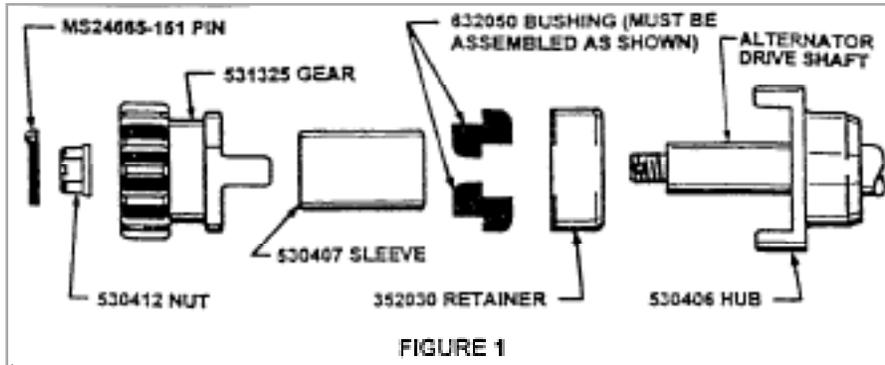
The oft-neglected drive coupling assembly showing the two rubber pieces and the “can” they go in and the wear pattern on one removed. The wear pattern will eventually pierce the can if let go long enough. Although the items are supposed to be checked every 500 hours, the step requires that the generator/alternator be removed for the inspection and it is often skipped and many are unaware of the service letter.

From a new catalog from Aircraft-Spruce, this table of parts for the generator is copied. Every few years, you are supposed to replace the two item five rubber shock absorbers and their container, item 4, is often too worn to keep and so should also be replaced. The prices are higher now of course and order two of the item 5. (Yes, Spruce has been told over and over that the starter gasket is in the wrong place. They like it there to confuse customers.) Note the cost of the special nut; there is a reason, it is special, and you won't be able to use anything else because of clearances. Don't lose it!

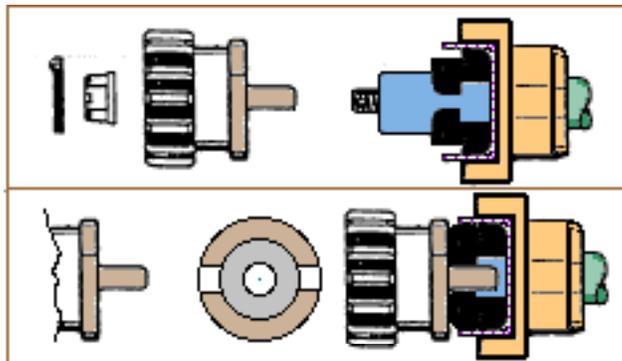
The source of the coupler information can be found in the February 1998 issue of the Light Plane Maintenance; they also note that the Teledyne Continental service bulletin is TCM SB#95-3A. It is believed that few mechanics are aware of the service note and its applicability to the C engines and the O-200. The “rubber” shock absorbers have a single unique shape and nothing other than this sketch has been found to indicate the correct orientation of them in the “can”. The figure renditions in the catalogs are so small and so poor that the shape details are not apparent. The figure from the Light Plane Maintenance article has lots of errors....the hole in the “can” is too small for the sleeve, the sleeve is shown sectioned but its internal diameter should be the same as the drive shaft and the drive shaft is depicted as being hollow, but is not. Here is a figure I created showing how the parts are supposed to nest. The top rendition copies the LPM figure in that it shows the cushions as their ends would appear; the bottom shows the cushions as if sectioned in the middle and are a truer display.

This view is correct because Jim Williams did some research and confirmed that the image from Light Plane Maintenance is the right way. Later, I show lots of views of the cushions so you can see the right orientation. At the end of the article, I have included the generator-pertinent parts of Jim’s email; if that does not convince you that taking off the generator/alternator for a look at the next annual is worthwhile, I don’t know what will. Order the cushions! Remember, the A&E is obliged only to “confirm that the accessories look all right from the outside”. And log the special event and the new cushions.

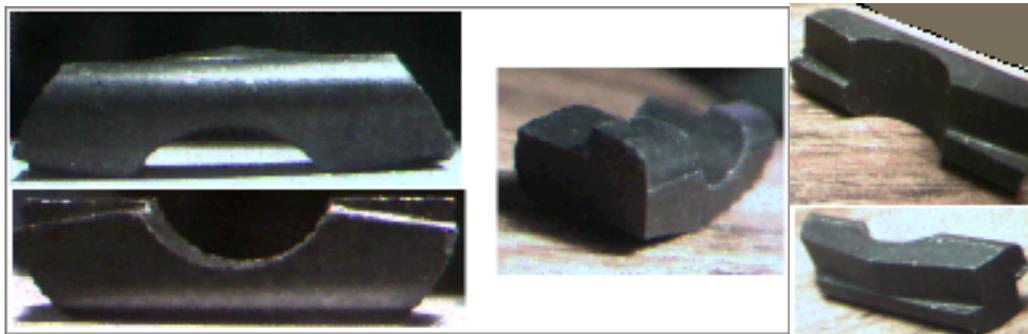
Details of the cushions look like this. The original parts were without all these special features. These are not shown anywhere else so this greater than usual display of pictures to indicate the details.
