Elevator Trim Tab Allowable Free Play

August 2005 Cessna 120/140/140A

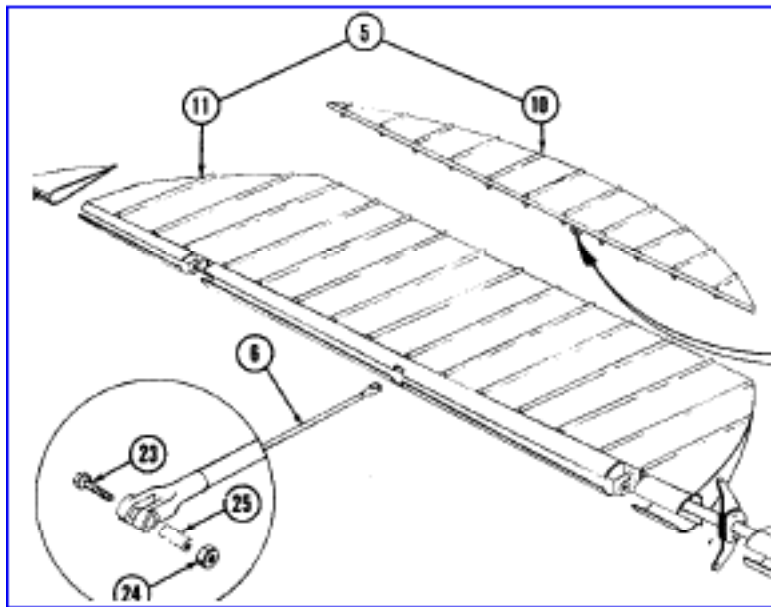
The span of the trim tab on our planes is greater than 35 percent of the span of the elevator.
