Static System Features, Results, and Symptoms

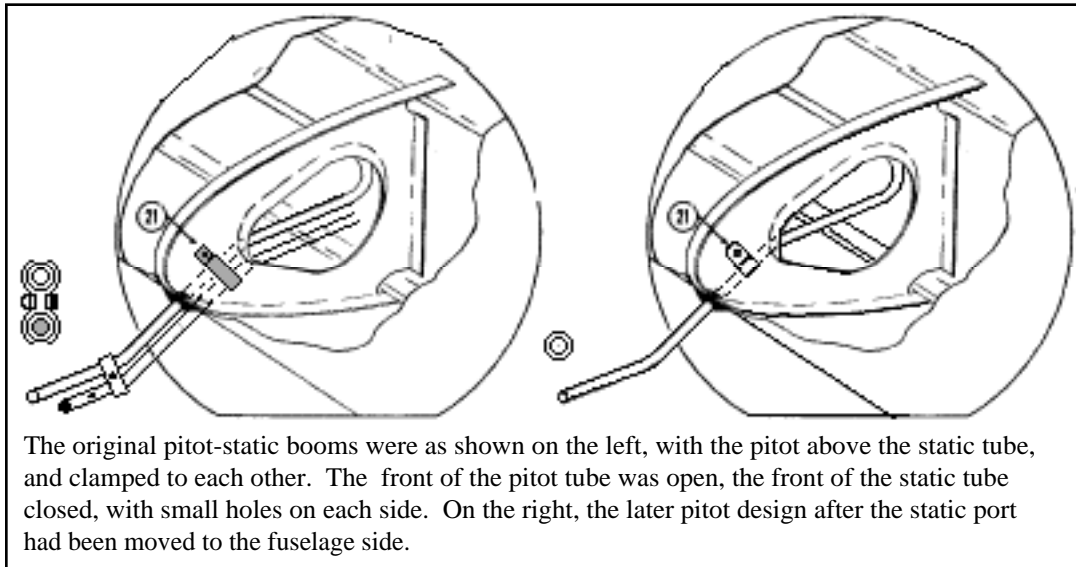
Static port placement is black magic, often going awry. The first 120/140 planes had two forward-facing tubes on the left wing, with the static closed-end pipe under the pitot port, and the actual static ports were holes on both left and right sides of the static tube. It was expected that the static tube would stay aligned with the centerline of the plane but any tilt away from that can introduce some pressure into the static system and that could cause an error in readings.

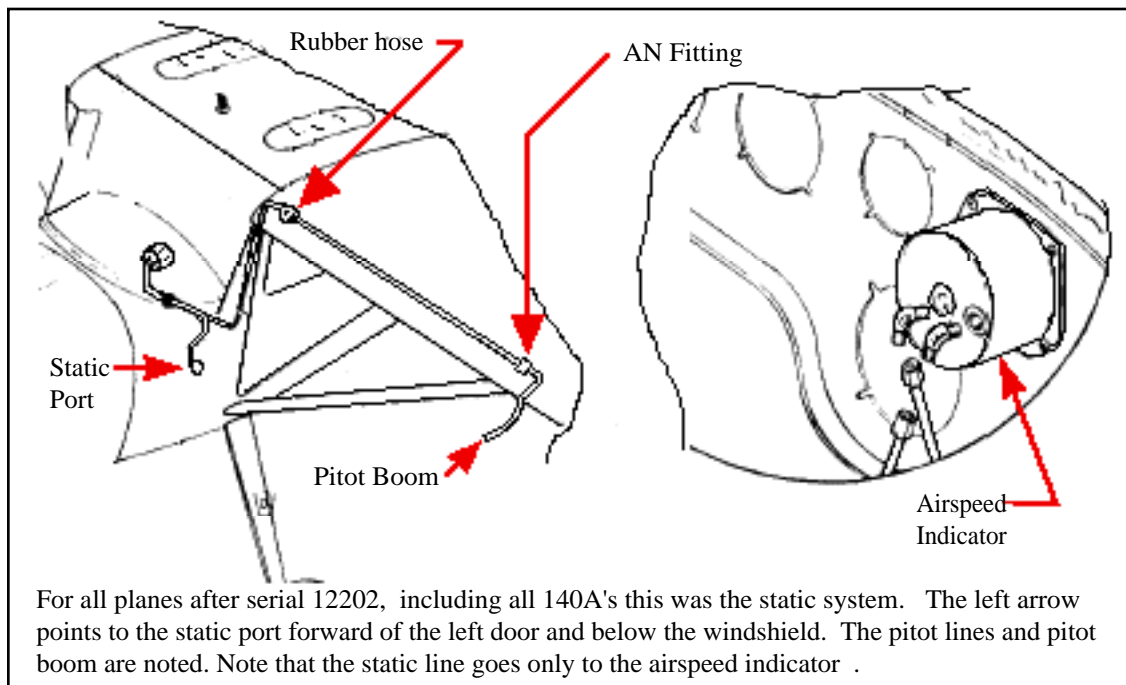
The static port was subsequently moved to the left side of the airplane, just forward of the left door and about in line with the bottom hinge as in the next figure. After the change and until the 12201 serial plane, the static system would have been routed to the altimeter, air speed indicator, rate of climb indicator (ROC or VSI if installed) and recently to the encoder. The next figure was taken from the 140A parts manual and the pertinent lines of the figure were accentuated; this shows the routing of the static port only to the air speed indicator for all planes after serial 12202. The relative positions of the two ports is indicated.

It was found that neither the wing-mounted static port or the fuselage location for the port would always provide the correct static pressure to give proper readings on the instruments noted.

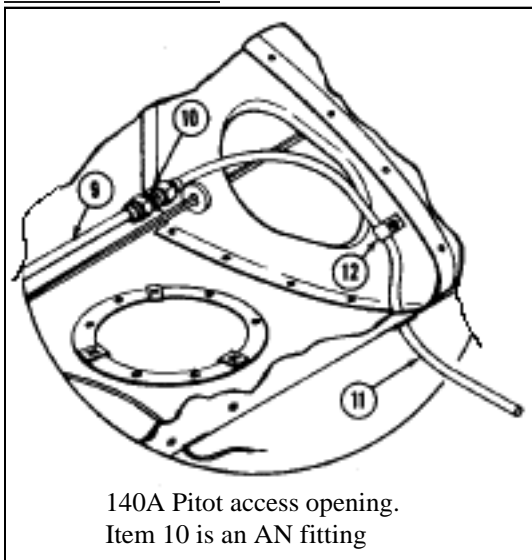
1. Cracked hoses, especially those in the left armpit which join the tubes from the older pitot-static probes to the tubes which carry the pressures to the instruments; there are two tubes so two rubber hoses and in the newer planes there is only one hose there. In the second drawing, note the connecting hose and also note that there is an AN fitting joining the long tube to the actual curved pitot tube port. Just under the AN fitting, there is an access hole in the wing for the A's for that fitting. Leaky hoses can both let pressure escape and absorb greater pressures.
