Pull Starter Plunger Seals

The Constant Drip Drip Drip from the Pull Starter Plunger Seal/Continental Engines

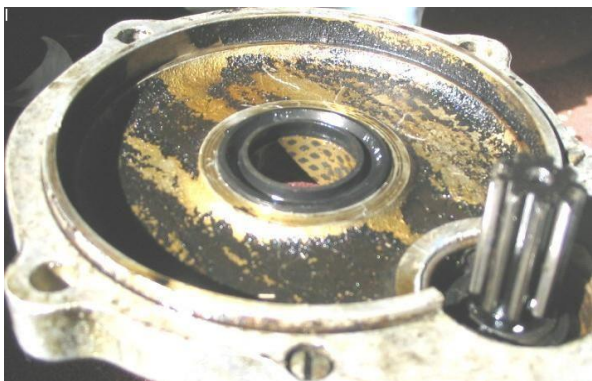
Old 'National' seal. Why is it raised?

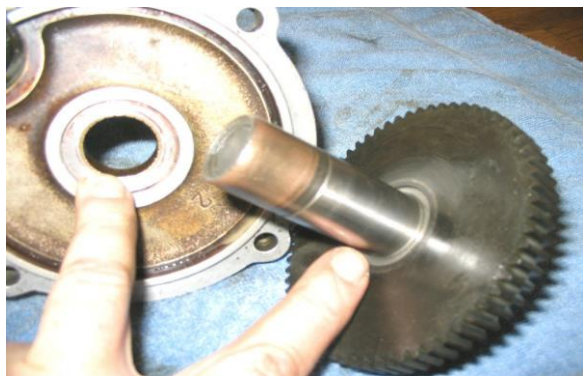
Ring around the spur gear, hmmm

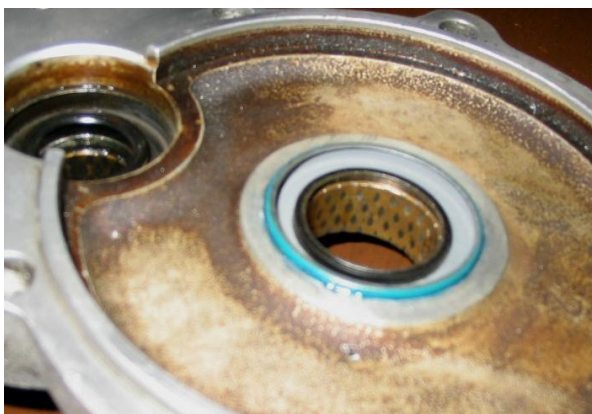
New CR seal, still not right
