CESSNA 120/140/140A TAILWHEEL Spring Set Details, Mysteries and Secrets

History and Mysteries and Corrections:

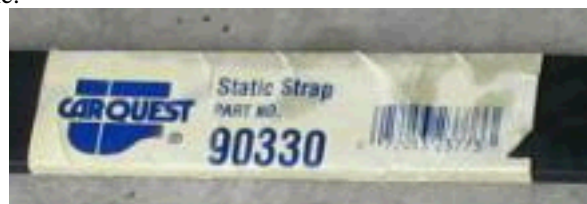
Dave Sbur sent a note and picture of a part he found at the auto parts store. One inch wide, plenty long and 3/16ths thick Neoprene.

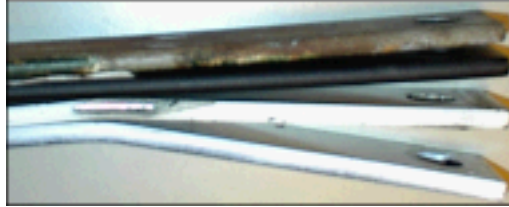
The world has changed again and now we can take actual pictures of the features of the springs. In this first set, showing the front ends of the main leaves, the top one is from a green 140, history unknown, of the ‘46 variety. The next, the black one, is a brand new one intended for a 120 with a single bend set. The bottom one is brand new, part of a double bend set, and the one above it is the fatigued double bend main leaf.

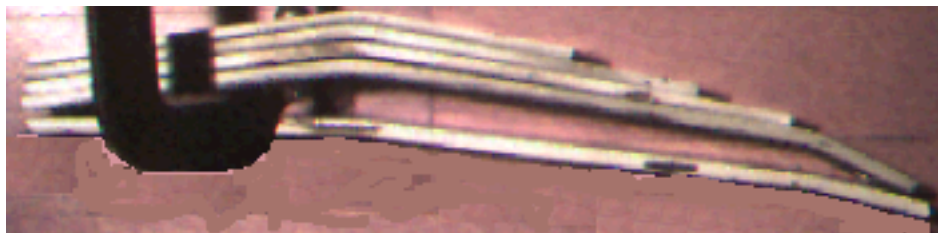
For the double bend new main spring, the front bend is between 12 and 13 degrees and the aft bend a precise 15 degrees. When the weight of the tail is on the tailwheel, those angles change.

Seeing is believing and the amount of fatigue-induced change in the two bends is evident here when showing the new set and the removed main leaf which was once the same shape as the new main leaf.

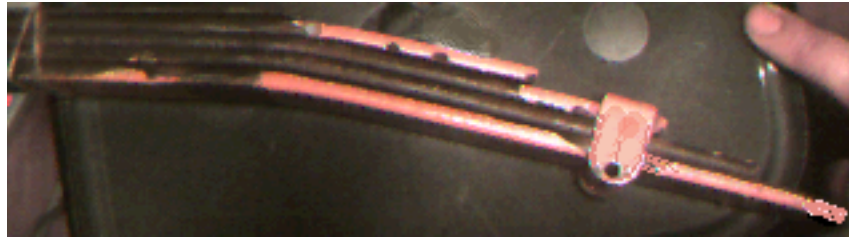
Next, a tailwheel spring set from an early '46 140, within the first 1200 manufactured. Note two things;

1. there is a “front bend”, about 5 inches behind the front end of the leaves, and
2. there is no rear bend.

This array conforms to the Scott I-168 installation for the model 3200 tailwheel for the 140 with respect to there being no rear bend, though one cannot be sure if there is a front bend in their figure. Poor handling.
