Wing Metallization STC's Cessna 120/140's

The STC's

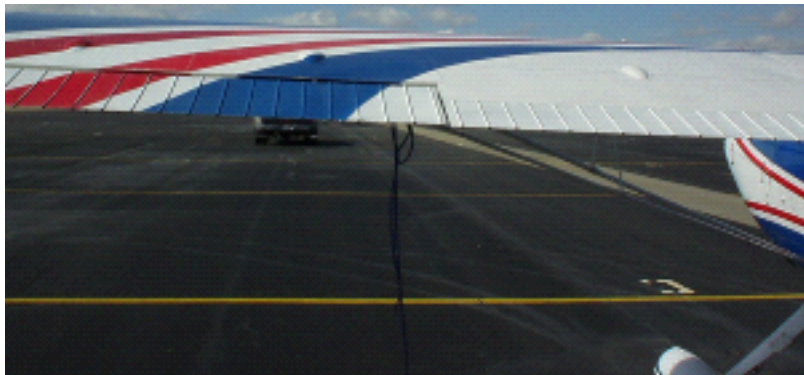
Later, we located a plane with the bumps and present a few pictures to illustrate the installation. Three on each wing.

If anyone can identify the STC or the STC holder...any information...for the metallization effort which included the little teardrop shaped covers over the bumps on the wing as shown earlier, let me know and I will modify this file to include that information. They look something like this, though not so high as indicated, but very nicely made and well shaped.

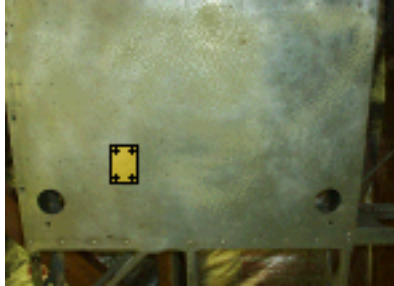
For those with fabric wings who have never seen the wing underside of the gas tank, all planes came with these bottom side covers. The two holes are to allow the installation of fuel tank drains and there are two so that the same piece of metal could be used on both the right and left wings. The data plate for some metallization STC installations would be about where indicated. Some of the metallization plans filled in or covered the outboard holes. For this view, imagine you are laying under the wing, feet to the tail, and looking up.

Some Metallization STC's included a data plate calling out the manufacturer and this plate is often covered with paint and is riveted (usually) to the bottom side of the bottom left gas tank cover. All the planes were made with the bottom skin of metal below the gas tanks (covered with fabric) and this was not double covered when the wings were metalized. Some STC's plugged the outboard drain hole in both of these covers, some did not. At least one STC included teardrop shaped covers over the junctions where several layers met, and these covers stand proud of the top of the wing (and add a certain cachet to the covering).
