Cessna 120/140

Upper and Lower Door Hinge Blanks

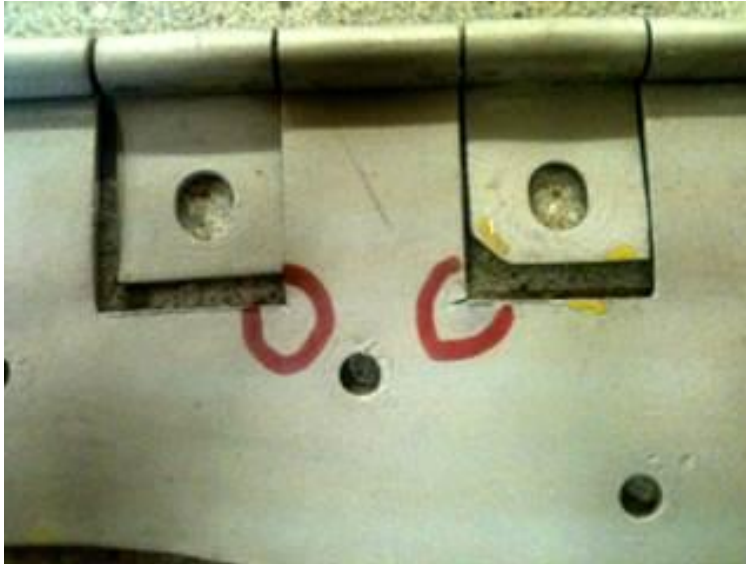
The stock upper hinges tend to wear in two ways: 1) the hinge pin wears the thin aluminum of the hinge eye, sometimes to the point of the hinge eye breaking away and 2) cracks often develop in the square corners of the hinge, as shown in the photo below.

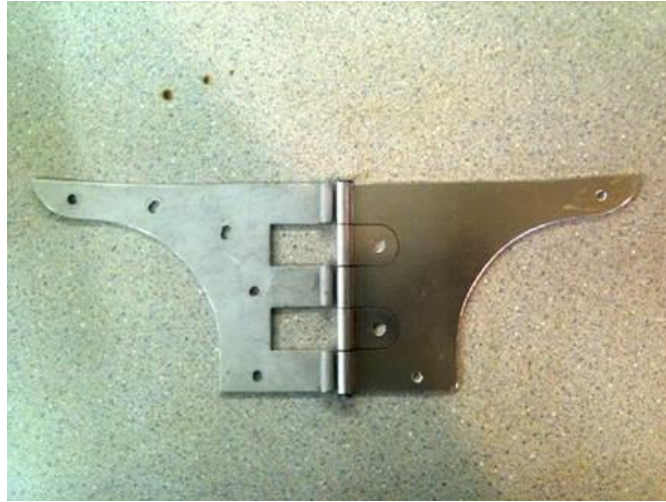
The photo below shows a new left-hand hinge cut from the blank as compared with a stock unreinforced (early configuration?) hinge.

- Thicker material than stock hinges--.062" versus .050"--resulting in less tendency to wear and crack.
- The small hinge lobes are rounded (as compared with stock hinges that have square corners), resulting in much less tendency to crack.
- Ability to add a reinforcing plate if desired--a better way than with reinforced stock hinges--resulting in even less tendency to crack.
- Larger hinge pin diameter--.125" versus .093"--resulting in more bearing area to improve both radial and axial hinge wear.

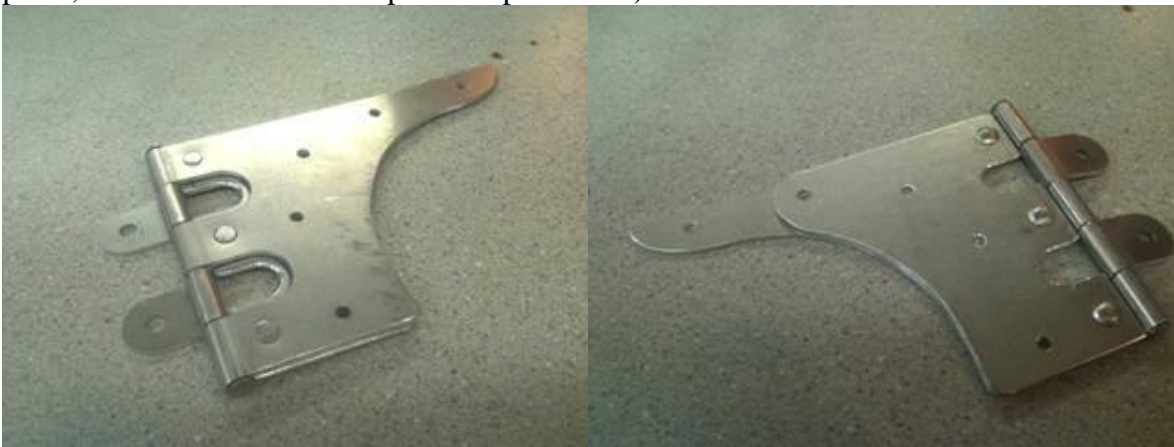
The photos below show a new right-hand hinge reinforced with an added plate, similar to the way some (later configuration?) stock hinges were built. (However, the reinforcing plate used in the stock hinge was spot welded in place; cracks tended to develop at the spot welds.)
