# **G**ENERATORS

For the 120/140/140A's

## **Generators for the Continental C-85, C-90, and O-200 Engines:**

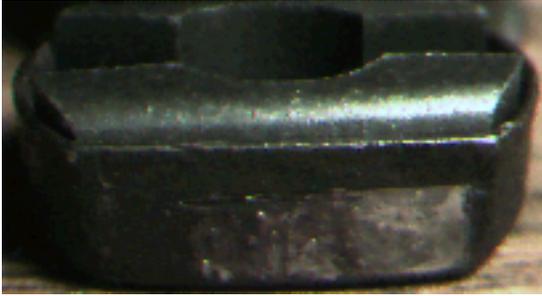
The oft-neglected drive coupling assembly showing the two rubber pieces and the “can” they go in and the wear pattern on one removed. The wear pattern will eventually pierce the can if let go long enough. Although the items are supposed to be checked every 500 hours, the step requires that the generator/alternator be removed for the inspection and it is often skipped and many are unaware of the service letter.

The source of the coupler information can be found in the February 1998 issue of the Light Plane Maintenance; they also note that the Teledyne Continental service bulletin is TCM SB#95-3A. It is believed that few mechanics are aware of the service note and its applicability to the C engines and the O-200. The “rubber” shock absorbers have a single unique shape and nothing other than this sketch has been found to indicate the correct orientation of them in the “can”. The figure renditions in the catalogs are so small and so poor that the shape details are not apparent. The figure from the Light Plane Maintenance article has lots of errors....the hole in the “can” is too small for the sleeve, the sleeve is shown sectioned but its internal diameter should be the same as the drive shaft and the drive shaft is depicted as being hollow, but is not. Here is a figure I created showing how the parts are supposed to nest. The top rendition copies the LPM figure in that it shows the cushions as their ends would appear; the bottom shows the cushions as if sectioned in the middle and are a truer display.

From a new catalog from Aircraft-Spruce, this table of parts for the generator is copied. Every few years, you are supposed to replace the two item five rubber shock absorbers and their container, item 4, is often too worn to keep and so should also be replaced. The prices are higher now of course and order two of the item 5. (Yes, Spruce has been told over and over that the starter gasket is in the wrong place. They like it there to confuse customers.) Note the cost of the special nut; there is a reason, it is special, and you won't be able to use anything else because of clearances. Don't lose it!
