Oil Temperature Assembly for the Continentals

Mis-Matched Scott Oil Temp Assemblies The Path to Here:

SERVICE INFORMATION LETTER

P/N 13340-00 OIL TEMPERATURE GAUGE (FORMERLY REFERRED TO AS RN-2100 OIL TEMPERATURE GAUGE)

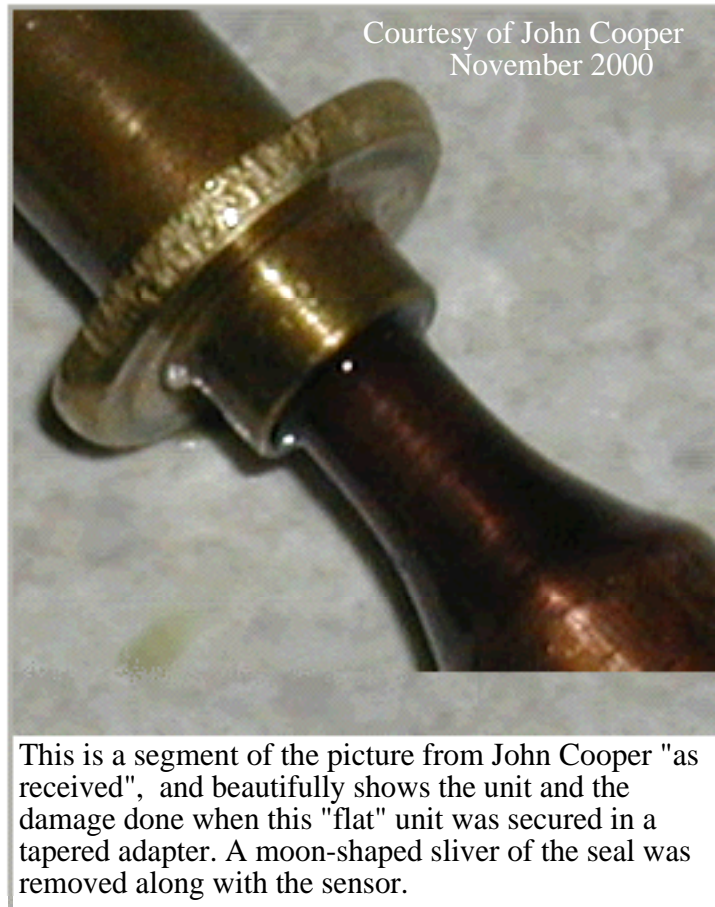
Originally, the planes were issued with oil temperature assemblies made by Rochester. A split resulted in the present different companies of Scott and Rochester. Many buy their replacements via the aviation parts catalogs, and the listings in all of them are incorrect. In Aircraft Spruce's catalog, the Rochester lists the

mounting hole (correct at 2-1/16"), but states that the unit comes with a "1/2" NPT adapter nut". Below on that page, the optional adapters are listed, one with 5/8-18 internal and external threads (Continental) and the other with 1/2 NPT and 5/8-18 threads (Lycoming?), with you left to guess which threads are internal and which external. The adapter for our engines requires the 5/8-18 internal and external type. The Scott listing leaves off the size of hole the unit will fit, but does list the female capillary adapter fitting as 5/16-18 (yes, five sixteenths, a diameter/thread combination that does not exist and would fit nothing). On a previous page, the correct adapter is listed, with its use to "shorten long capillary tubes". Its threads are correct, though the interior sealing surface, conical or flat, is not noted, nor is that feature noted in any of the catalogs. In the Wag-Aero catalog.....well, let's skip the details and state that it has like errors and omissions. The message? Take care when you order and make sure you have an adapter which will work with the shape of the new gage/sensor set.

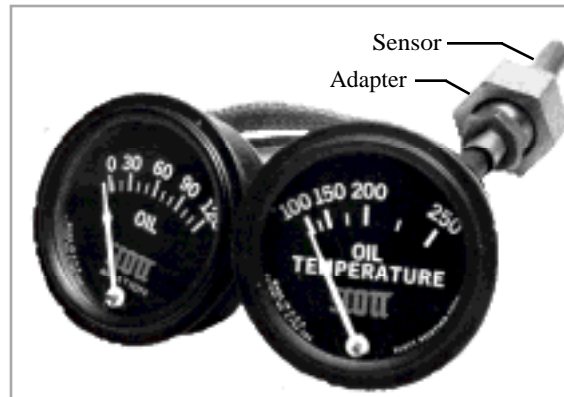
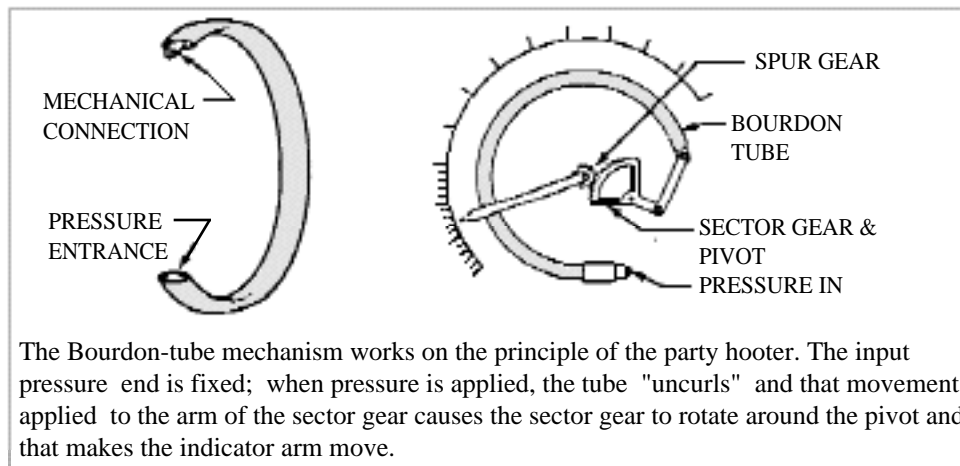
This figure is better than most of Scott's and it comes from the newest Avial parts CD. Note the flat surface areas for sealing between the adapter and the sensor. This is the only figure I know of which has the dimensions, but is incorrect in that the 5/8-18 internal threads and the 5/8-18 external threads should have the same diameters. Sigh. I present it here because of the dimensions, especially that of the meter body diameter, a number often misleading in the catalogs.

Every vendor should be shipping the Kit noted in the Scott service letter which follows in this article. No one should accept piece parts as was the normal listing and procurement noted earlier on this page. When you get the kit, use all of the parts, and discard the old adapter and the sensor and gauge.

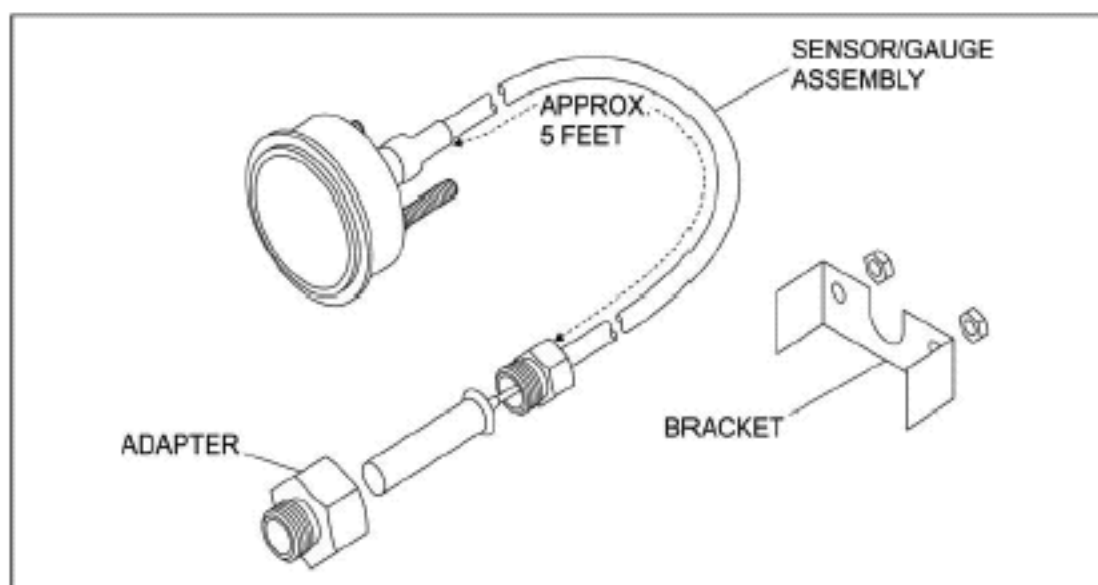
Figure 1
Complete Scott Oil Temperature Gauge

This SIL applies to all Scott P/N 13340-00 oil temperature gauges. A typical oil temperature gauge is illustrated in Figure 1.

If the wrong adapter is installed, the mating surfaces may not seal. For example, if a new gauge is purchased, but the already installed flat-faced adapter is not removed and replaced by the new adapter, then the conical mating surface of the sensor and the compression nut will not seal with the old flat-faced adapter. Installation of a new gauge with a conical flange and compression nut into an old adapter with a flat surface can result in damage to the sensor and loss of engine oil.

When installing a replacement gauge, it is critical that the compression nut, sensor bulb and adapter making up the complete oil temperature gauge be installed together. Make sure to remove the existing adapter from the engine, then install all three new parts.
