## " JUST A LITTLE TRIP AROUND THE PATCH"

### THE GAS CAP STORY:

Submitted by: Neal F. Wright

### THE CULPRIT, THE SILICONE VALVE

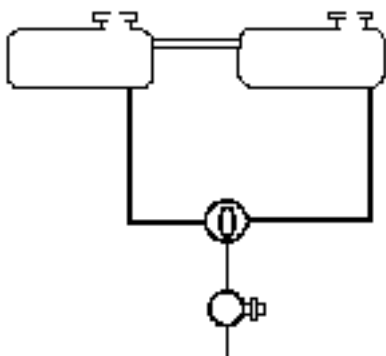
The "normal", as-designed Cessna 140A fuel system, again simplified and stylized to show only that there is a tank vent interconnect tube attached to the new top-of-the-wing vent. It is obvious that, if the single vent is blocked by a hornet's nest or ice, there is no way to get fuel out of either tank after a vacuum develops from fuel outflow. The gas tanks are shown as though they have no filler openings or caps, though of course they do-----part of the problem is that, starting with the 140A, the gas caps were "blind", or ventless, so the venting was totally dependent on the new, external, common vent.

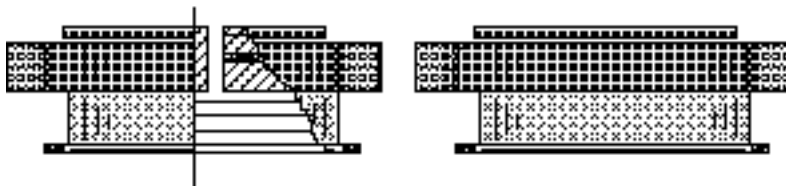
The original caps for the Cessna 120's and 140's look something like this, with the two vent holes as shown providing air inflow or fume outflow without restriction. They are both-way vents since fumes can exit and air can enter without any valve interfering.

If your plane is a 120 or 140 that has the new-style gas cap, and you don't want the hazard for an hour longer, but you have to get home, then you can render the half-vent caps full-vent by removing the silicone valve. For short term use, say a trip or two, the half-vented gas caps can be made safe for our 120/140's if the red silicone valve (that is what the manufacturer calls it) is pulled out, a step that can be easily accomplished; realize that a mechanic or fuel person might subsequently notice the silicone valve being missing, not know why, and re-install a new silicone valve or like cap since they are readily available at any Cessna FBO. The silicone valve itself is available for only \$5.00 to \$7.00 for the plastic cap model and \$12 for the metal model, so beware someone doing another favor by re-installing it when you thought you had disabled the valve. If you have one or, god forbid, two half-vented caps on the wrong plane, your Cessna 120 or 140, get that valve out of there, make a note in the logs, and go back to the original gas caps with their two-way vent holes as soon as you can!! Be safe.
