Cessna 120/140

Association

FEBRUARY 1980

NEWSLETTER

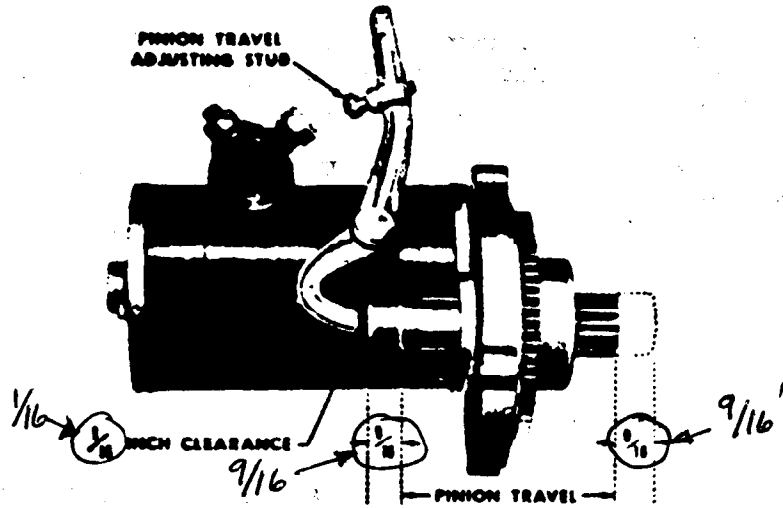
"To help eliminate possible starter gear failure, we off the following instructions: Make certain all switches are in the "off" position, then adjust pinion adjusting bolt to where the starter gears are fully engaged before the electrical contact is made in the starter switch.

The adjusting bolt on starting lever must be adjusted to provide 9/16 " travel on the pinion when starter switch is fully closed. The lock nut on adjusting bolt may have to be moved to the other side of the lever to obtain this adjustment.
