International Cessna 120/140 Association

DECEMBER 1980

ISSUE 37

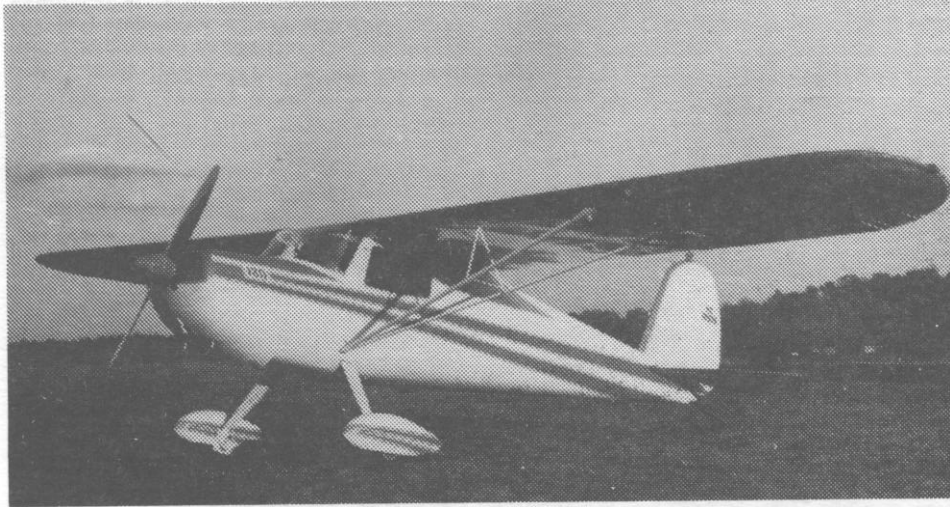
The following from Frank's letter: En-

closed is a picture of my Cessna 120. Although it was originally rebuilt a couple of years ago, we did it over again and made it a safe airplane. The first time, rebuilt legally in every respect, it was an unsafe airplane, believe me! But that's a story in itself. The second time Ron Degnan got involved and what had been passed off to us as being proper, performed according to the "system," was done over again, and there-in lies my tale of woe!
