Cessna 120/140

Association

APRIL 1981

ISSUE 41

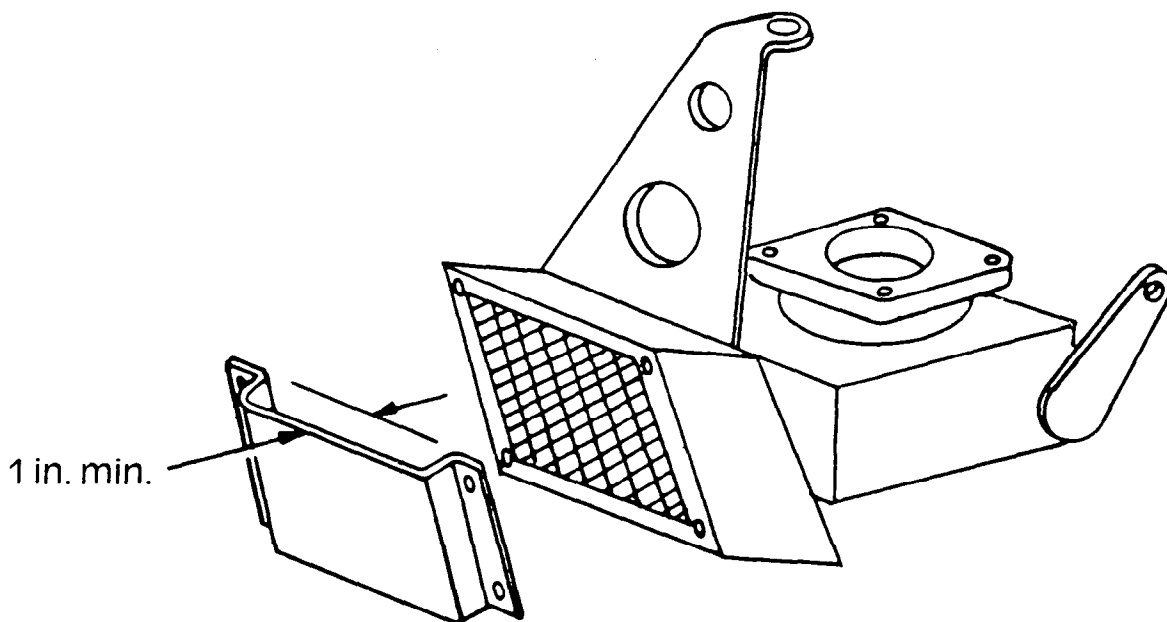
Service Bulletin - Cont.

perature can drop as much as 72°. This makes it obvious that in extended glides with closed throttle, power should be applied momentarily at frequent intervals in order to supply some heat to the carburetor air heater.

The foregoing is intended as helpful information to be remembered and applied whenever necessary. However, it is always a good safety measure to have a mechanical aid to help combat idling failures and we therefore refer you to the sketch illustrated above showing the suggested baffle arrangement which is very simple and can be very easily and economically made up and installed over the standard air filter. Our tests have indicated that this arrangement gives improved acceleration characteristics and minimizes the possibility of engine stoppage on sudden opening of the throttle.
