Light Plane Maintenance®

VOLUME 26 NUMBER 9

SEPTEMBER 2004

18 Continental O-200

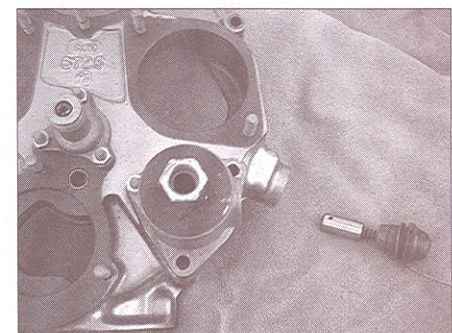
This shows the oil pressure relief valve/regulator valve removed from the accessory housing, showing the plunger, spring and cap, which is the spring and plunger guide. Also note the oil screen and oil temp bulb adapter installed in the screen housing in the accessory housing. If a Cessna oil filter adapter is installed, it takes the place of the oil screen entirely, screwing into the screen housing.
