## Pull Starter Plunger Seals

### The Constant Drip Drip Drip from the Pull Starter Plunger Seal/Continental Engines

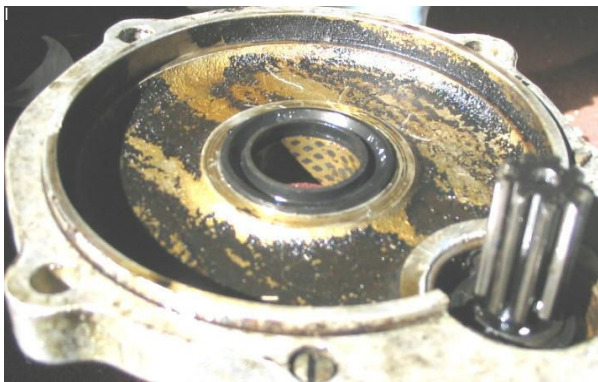
Old 'National' seal. Why is it raised?

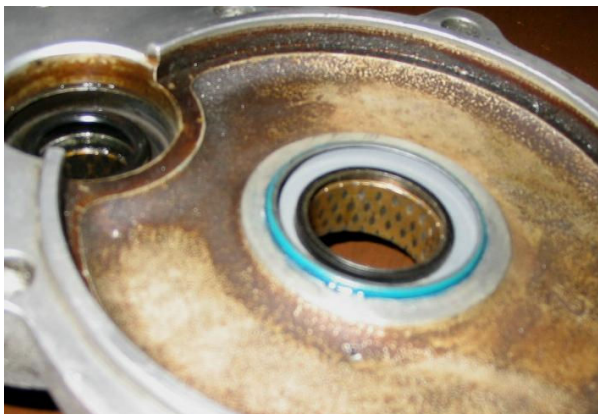
New CR seal, still not right

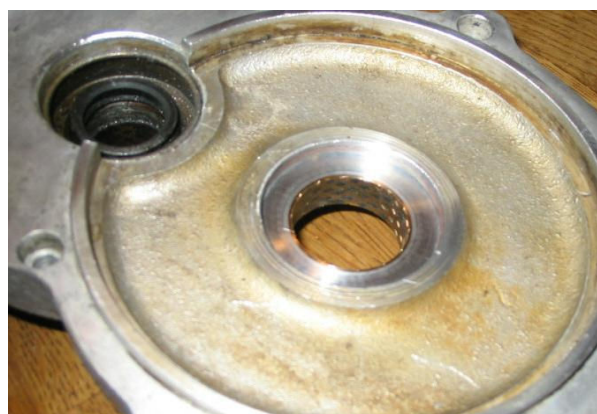
Ah, recessed correctly!

Inside near that coppery looking thing on the gear shaft is a spring that shoves the whole works back OUT of the accessory case, against the pinion gear pilot shaft, away from the crankcase gear. You know, that grinding sound you get on a bad day? Oh. So out comes the CR9859 and a little machine work occurs courtesy of a machinist A&P friend (sorry, don't know what he did here but he said it was easy), lower the whole thing about .060 more give or take to make things flush. No problems machining the Oilite bearing. In goes another new CR9859 and voilà! Life is good again. New starter plate gasket, reconnect everything (Niagara ditty has great instructions), and there is one less leak to deal with in the engine compartment. As far as bookwork, a mention of the starter mount no longer being a standard part (it's an old Delco-Remy part, remember?) and the seals used for any future replacements. (Oh, removing old seals is a bear, don't bugger up the plate-it's aluminum and soft. Pressing new seals in is easy!).
